-   Inspection Details
-   Structure, Foundation, Crawl Space, & Basement
-

## 1 - Inspection Details

## 2 - Structure, Foundation, Crawl Space, & Basement

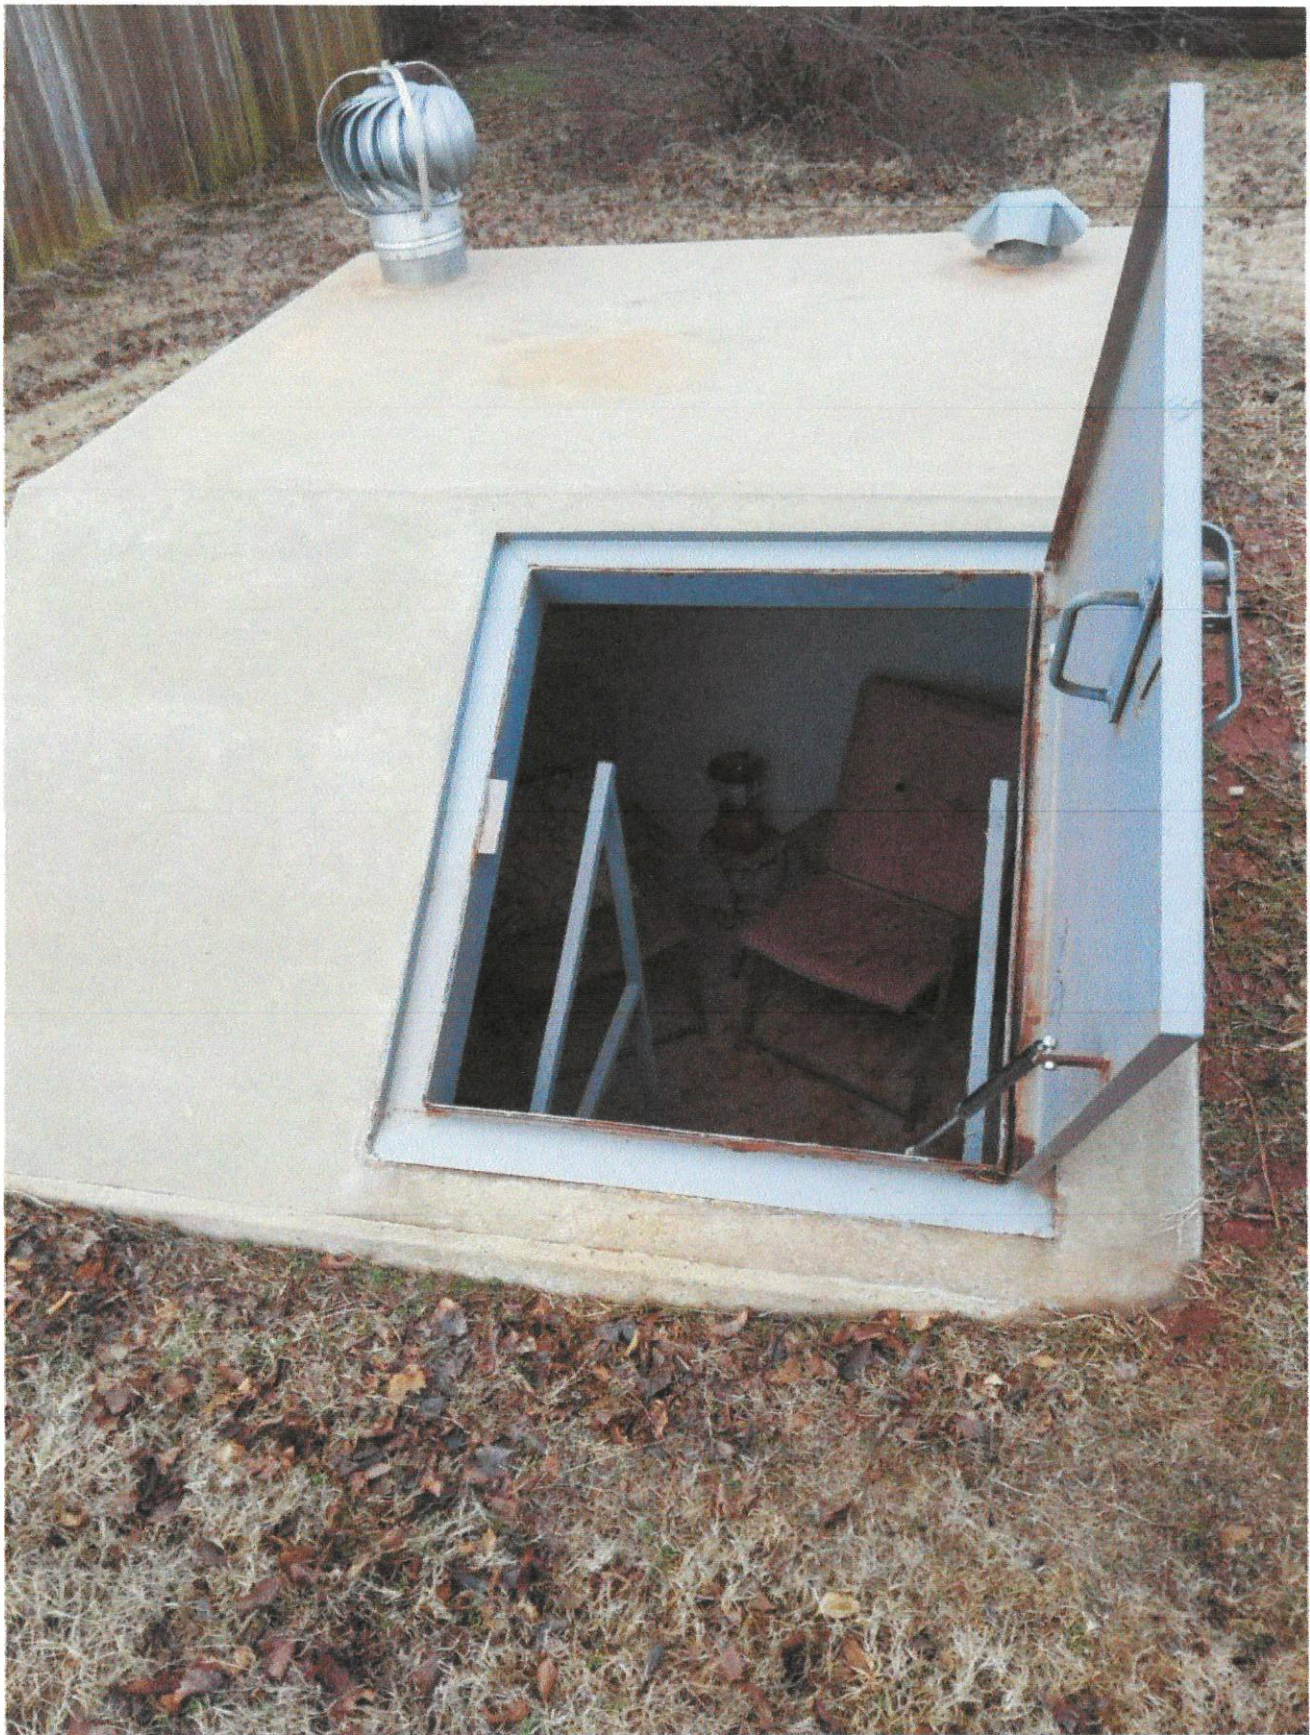
**Storm shelter**

Recommend registering the storm shelter with your local fire department or Emergency Management.

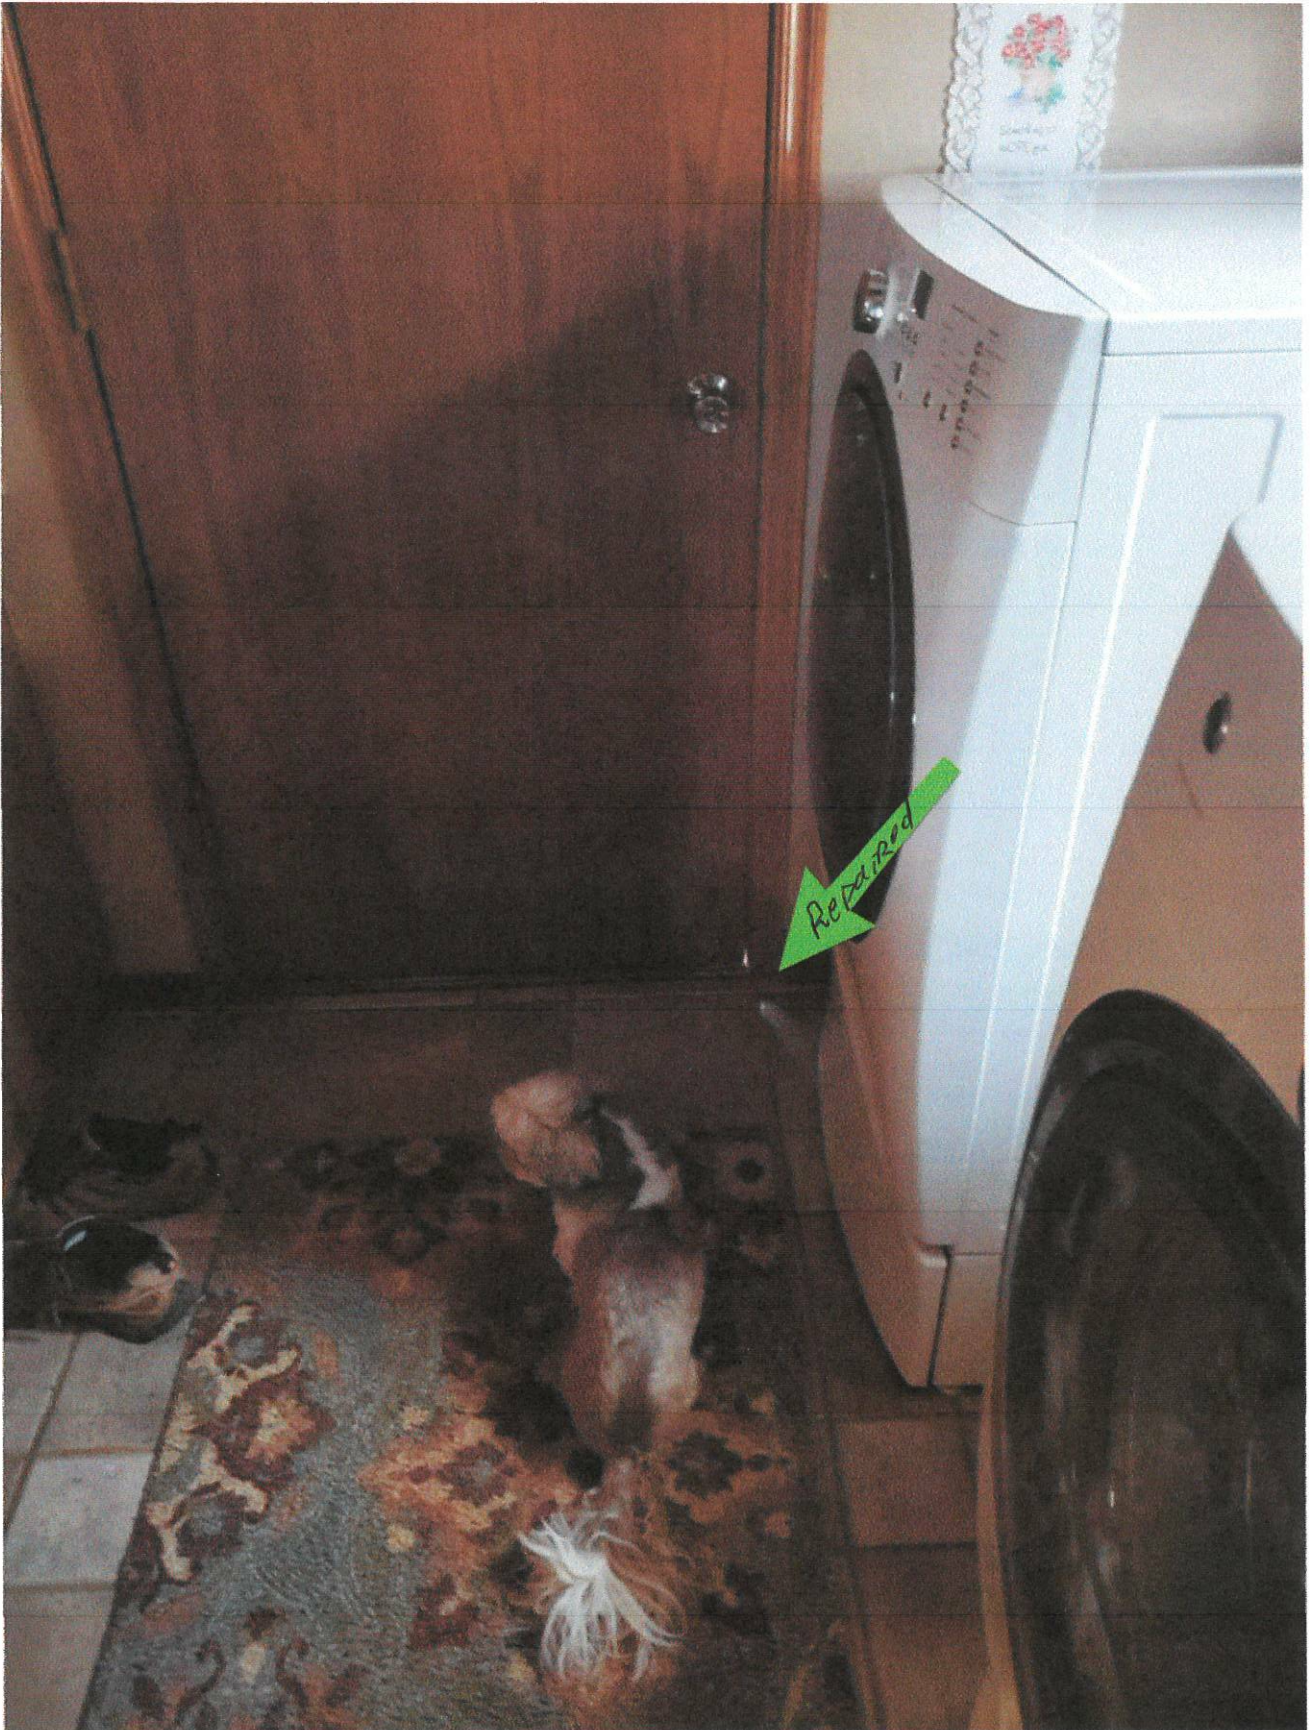
INFORMATION	LIMITATIONS	STANDARDS
<b>Siding, Flashing &amp; Trim: Siding Material</b> Brick		
<b>Siding, Flashing &amp; Trim: Trim Material</b> Metal		
<b>Exterior Doors &amp; Windows: Exterior Entry Doors</b> Wood, Steel, Aluminum		
<b>Walkways, Patios &amp; Driveways: Patios</b> Concrete, Common cracking Recommend maintaining sealant to help prevent further cracking.		
<b>Walkways, Patios &amp; Driveways: Walkways</b> Concrete, Common Cracks Seal as needed to help further cracking.		
<b>Decks, Balconies, Porches &amp; Steps: Appurtenance</b> Covered Porch, Front Porch		
<b>Decks, Balconies, Porches &amp; Steps: Material</b> Concrete		
<b>Eaves, Soffits &amp; Fascia: Eaves, Soffits, &amp; Fascia</b> Metal, Vinyl		
<b>Vegetation, Grading, Drainage &amp; Retaining Walls: Retaining Wall Material</b> N/A		
<b>Exterior Doors &amp; Windows: Daylight at door</b> — <i>Repaired</i> Daylight noted at the garage entry door, Recommend adjustments as needed.

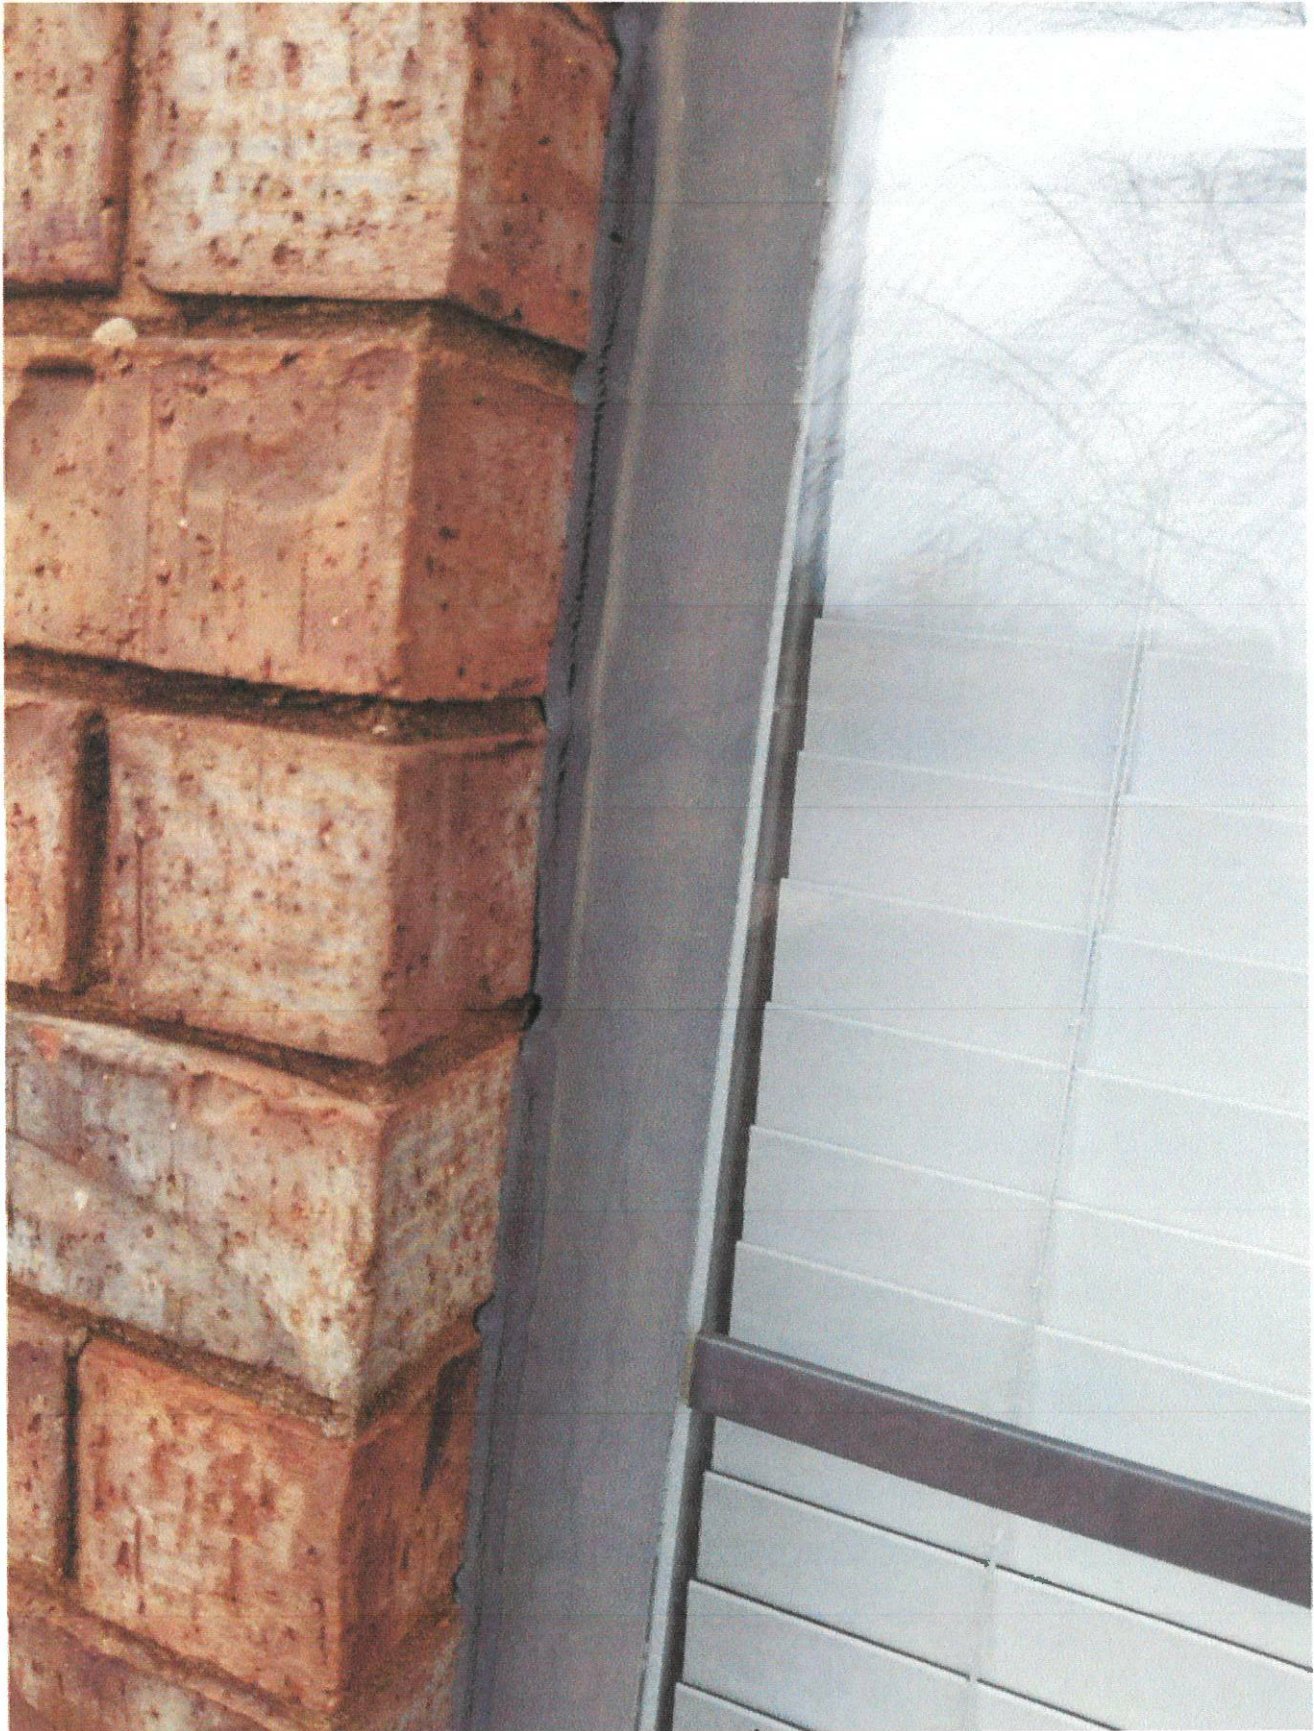
**Fencing: Damaged fencing**

Damaged wood fencing. Recommend repairs as needed.

*Repaired*

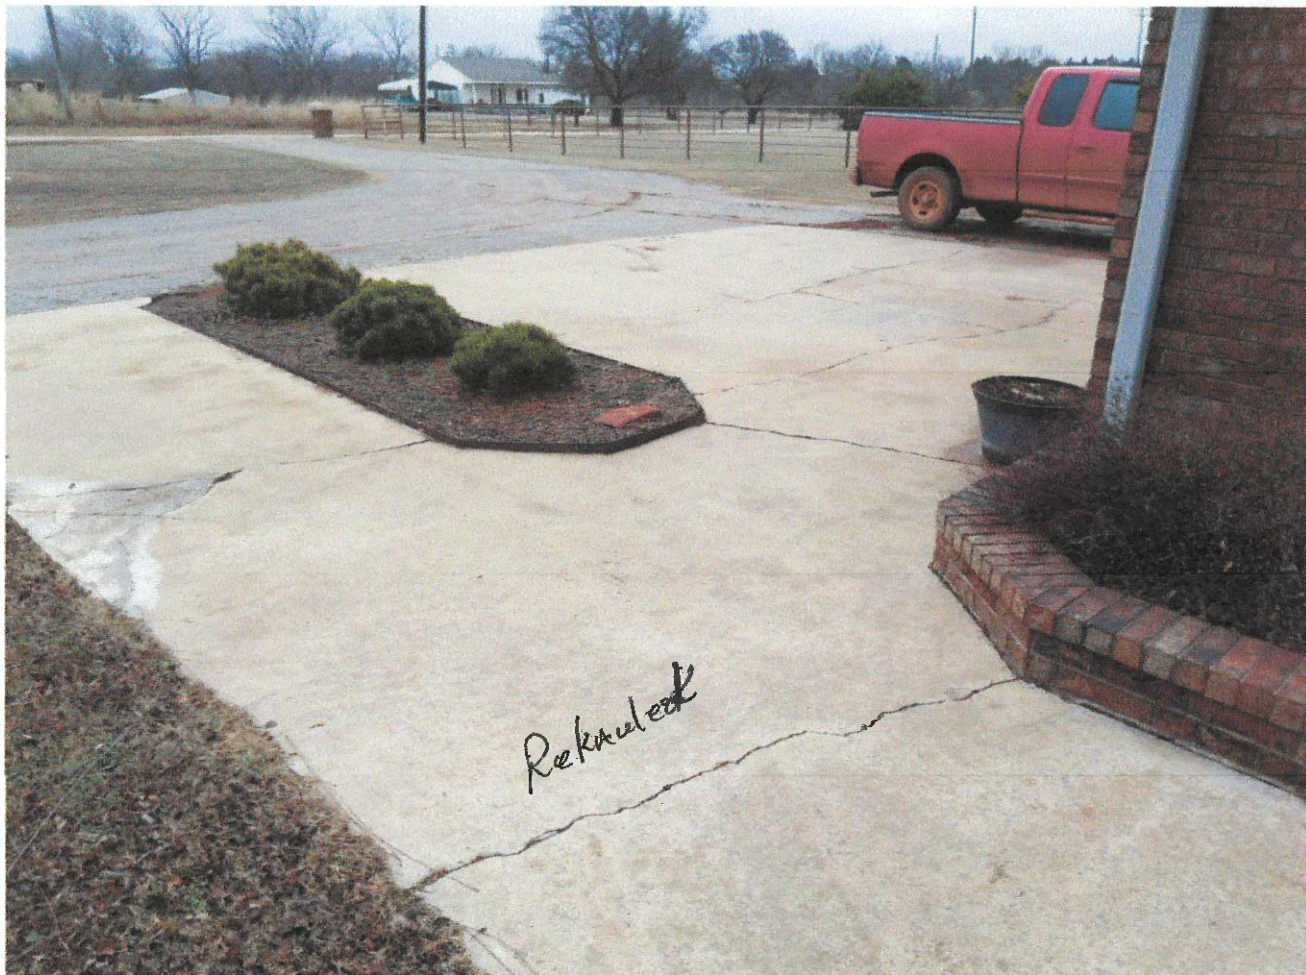
**Walkways, Patios & Driveways: Driveway Material**  
Concrete, Common Cracks

Suggest adding sealants to help prevent further damage or cracking.

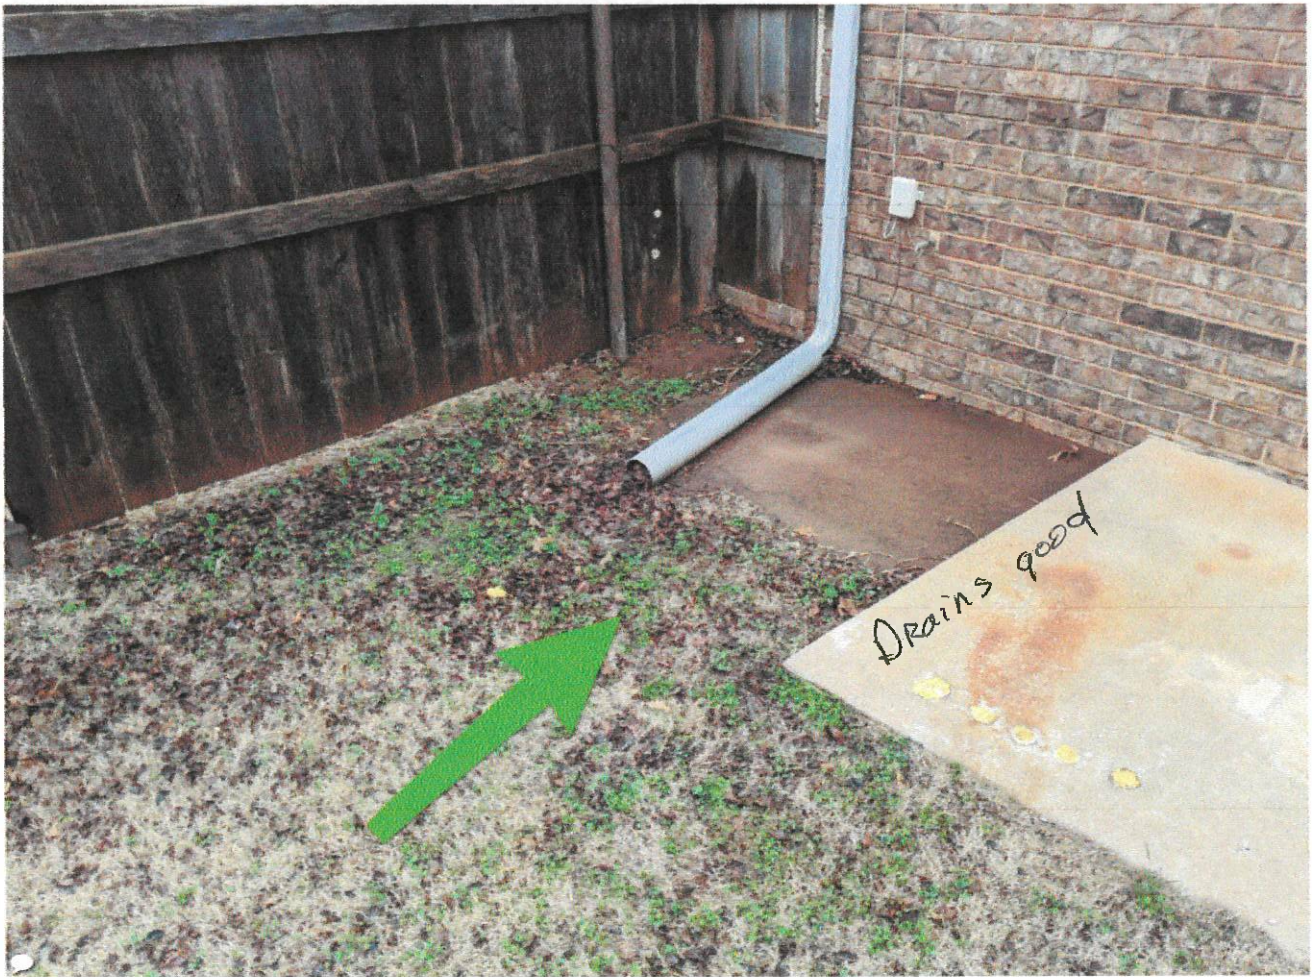
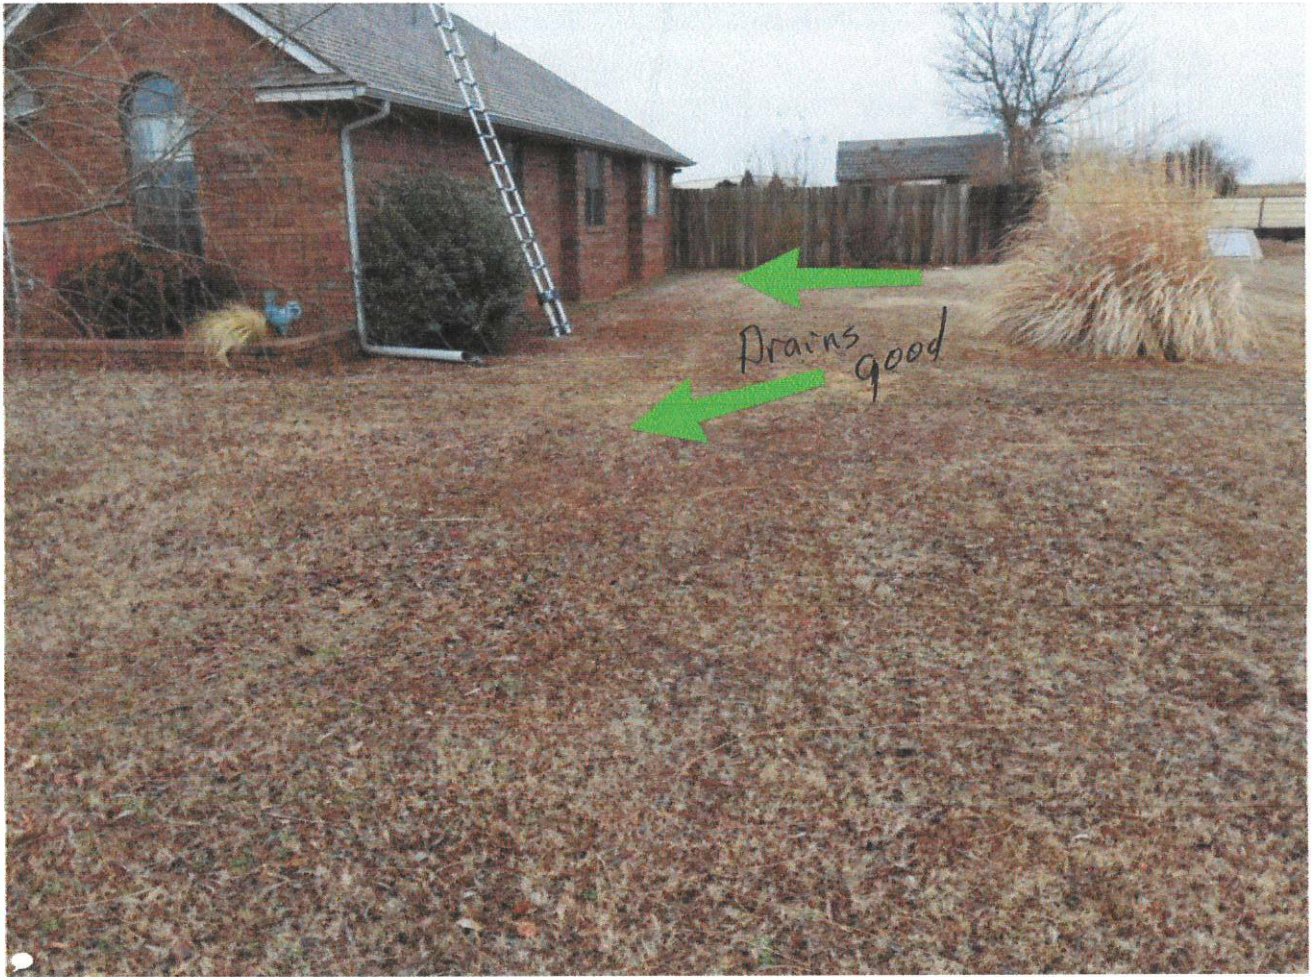
**Vegetation, Grading, Drainage & Retaining Walls: Yard drainage**

Poor drainage and or negative slope viewed at on or more areas around home. Recommend monitoring over time and repairs/adjustments as needed to provide proper drainage around home.

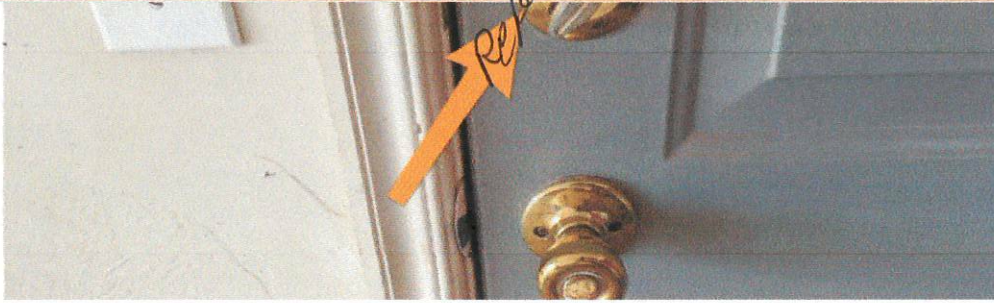
### 3.2.2 - Exterior Doors & Windows

#### DOOR DOES NOT CLOSE OR LATCH

Door does not close or latch properly. Recommend qualified handyman adjust strike plate and/or lock.

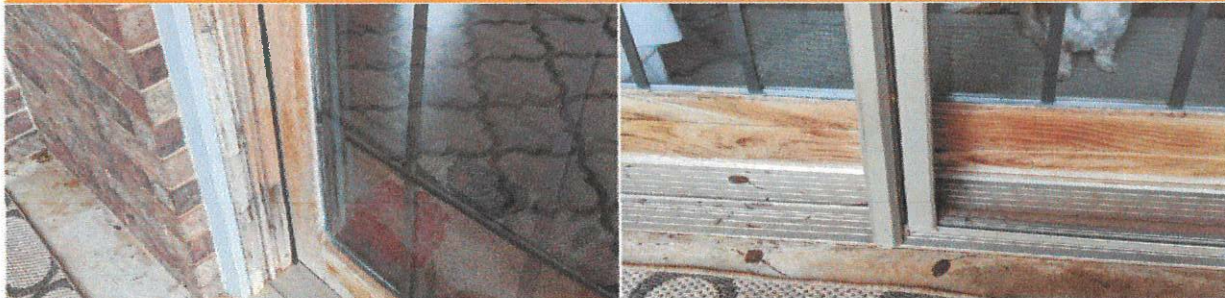
### 3.2.3 - Exterior Doors & Windows

#### PAINT/REFINISH NEEDED

REAR PATIO DOORS

Door finish is worn. Recommend refinish and/or paint to maximize service life.

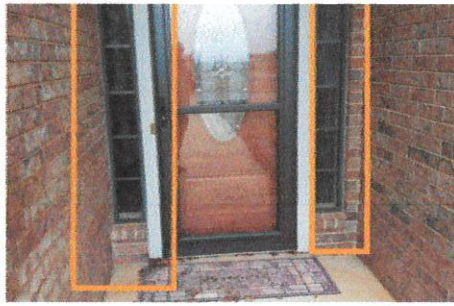
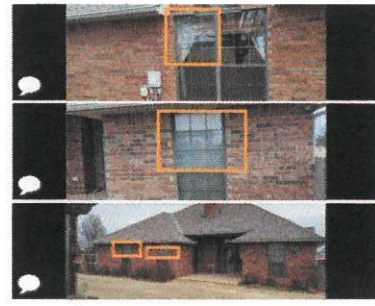
### 3.2.4 - Exterior Doors & Windows

## FAILED WINDOW GLASS

Failed window glass seal at multiple windows around home. Recommend a qualified window/glass contractor evaluate all windows for defective glass and repair/replace as needed.

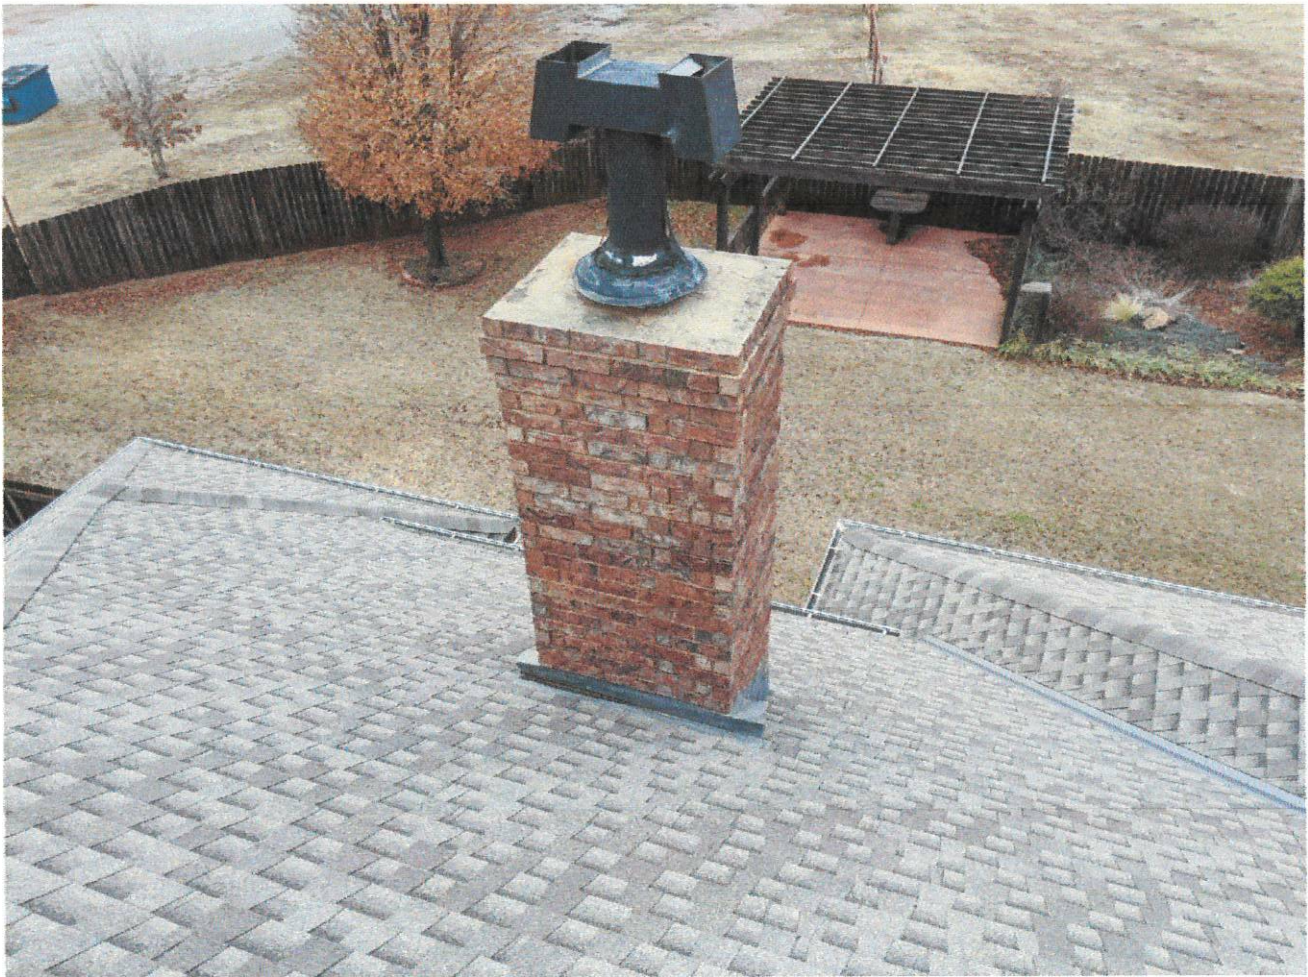
**Roof walked**

The roof was walk and no hail damage noted on shingle surfaced at time of inspection.

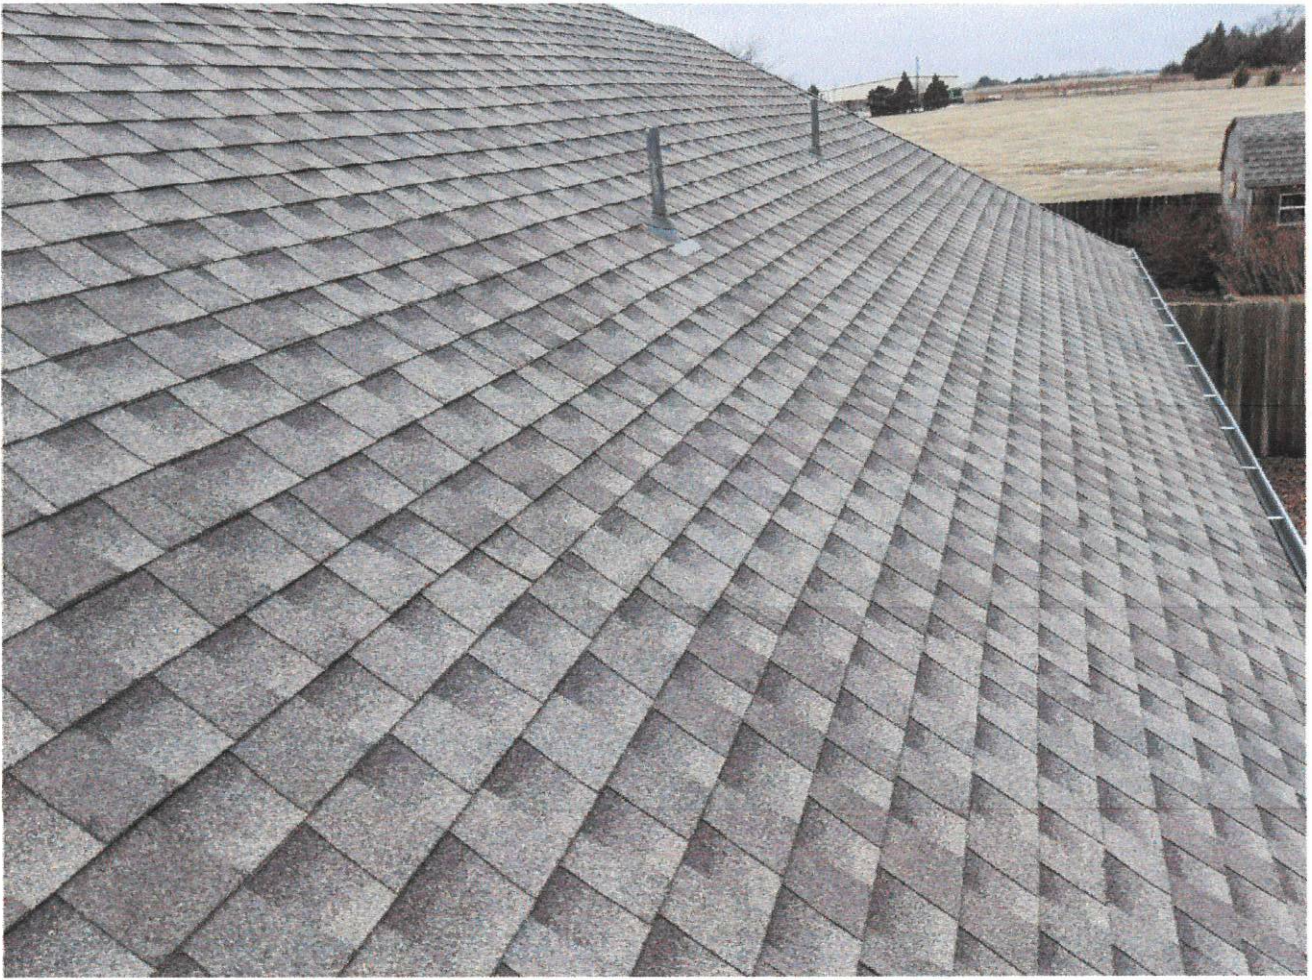
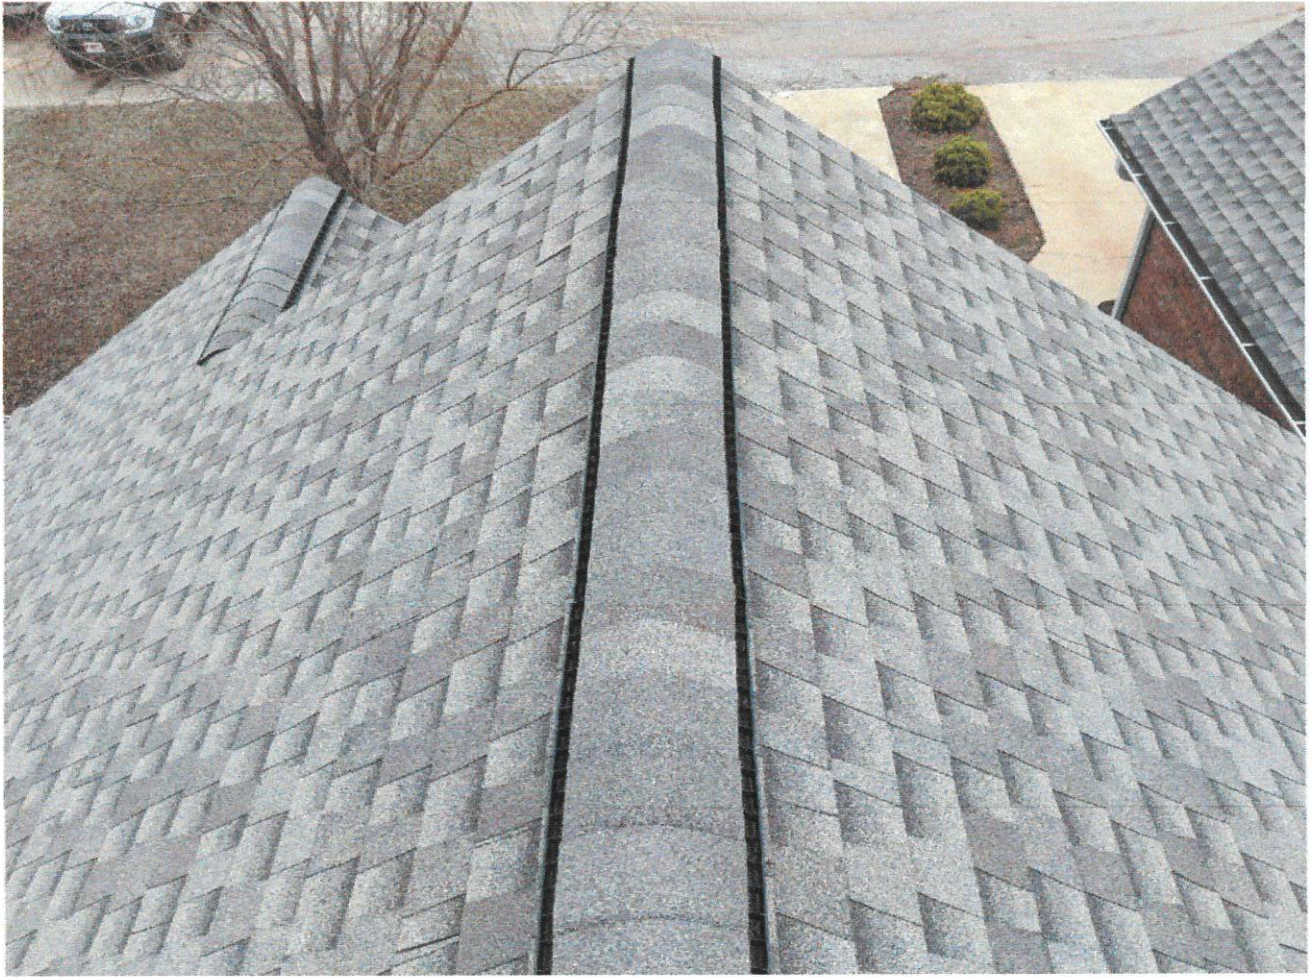
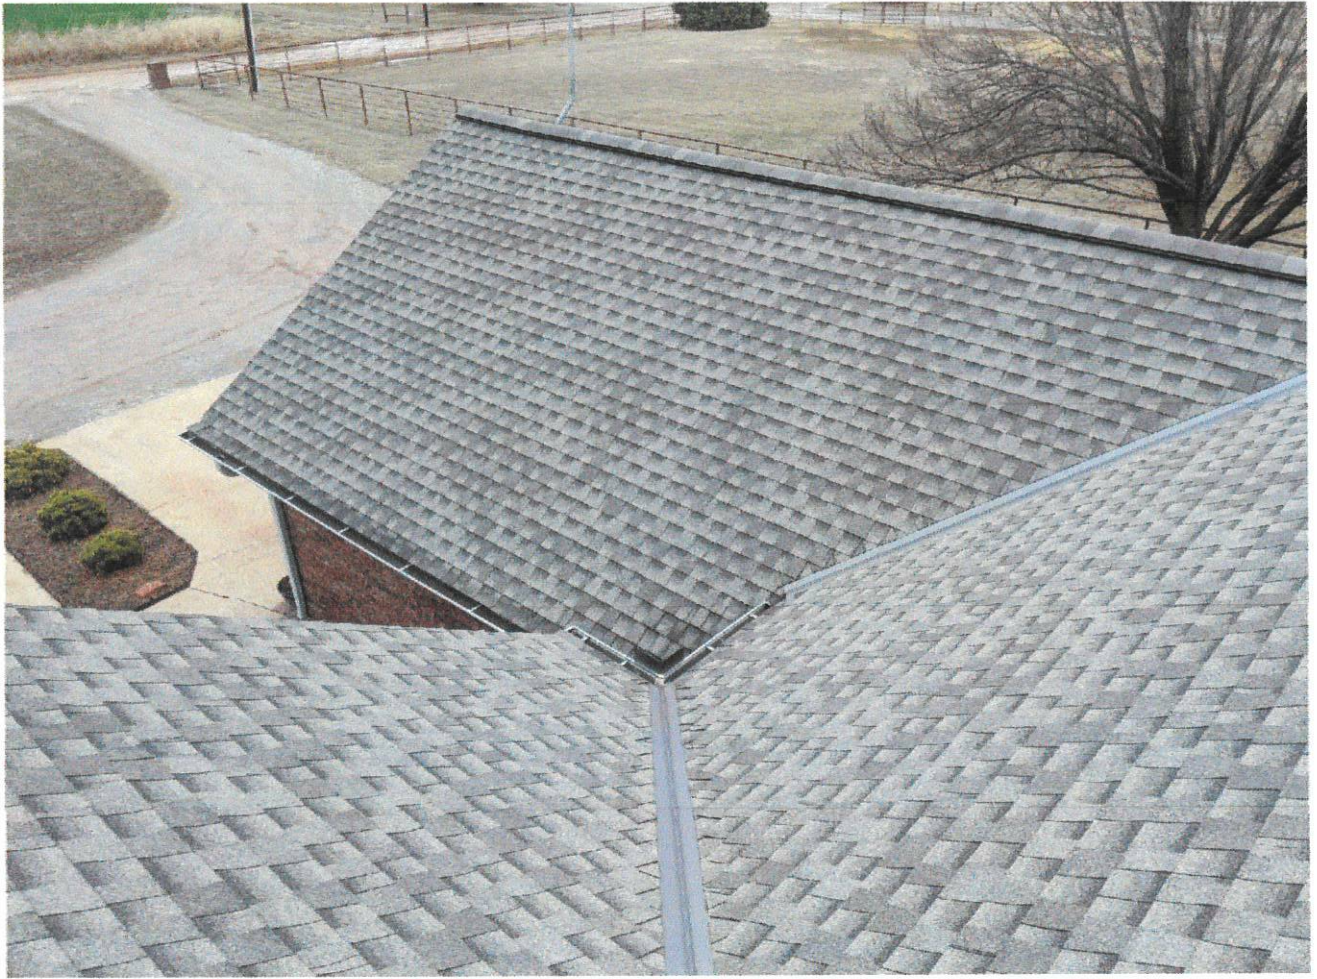
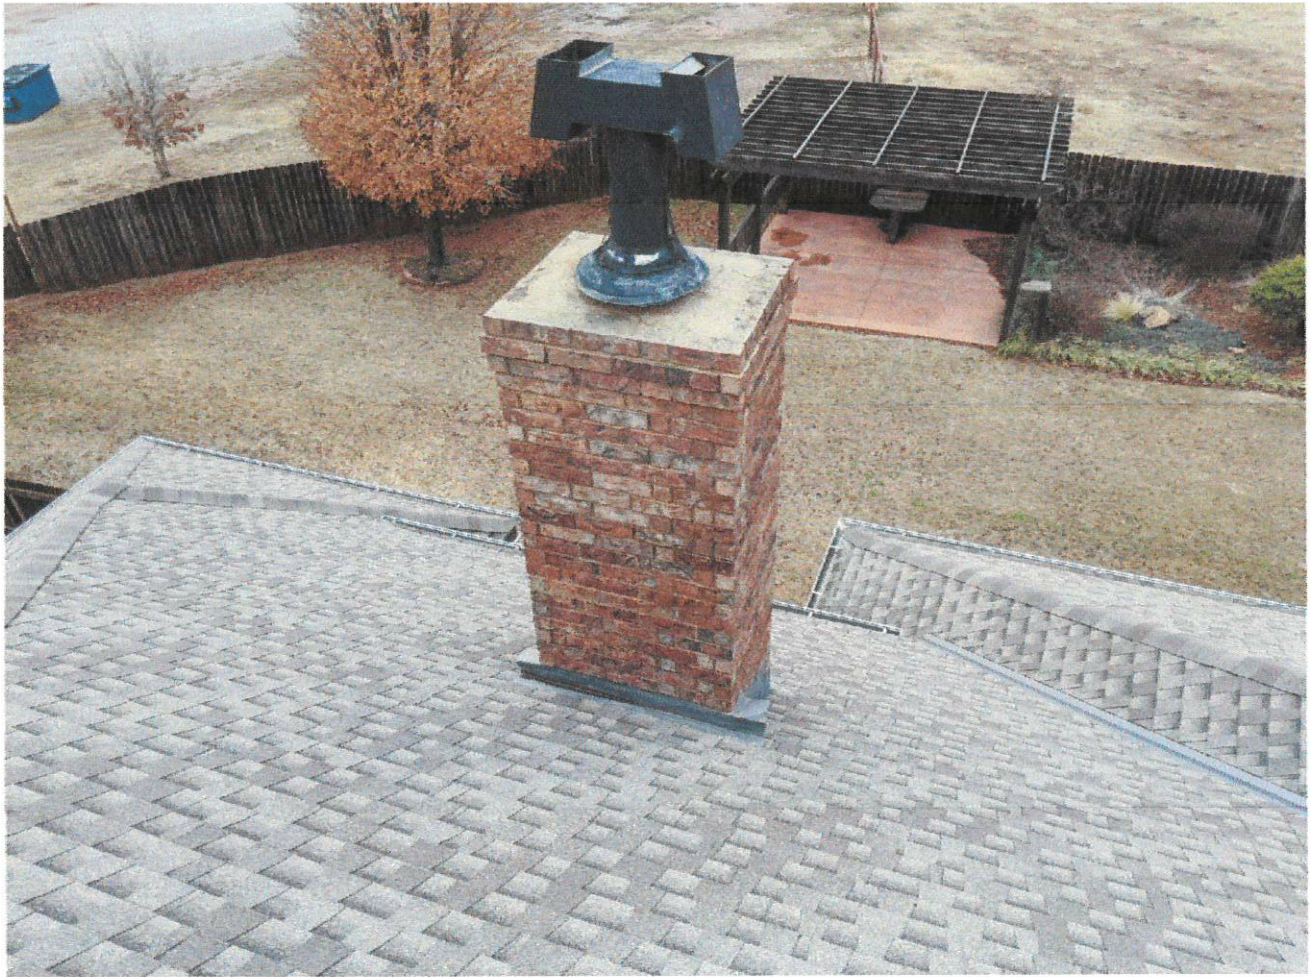
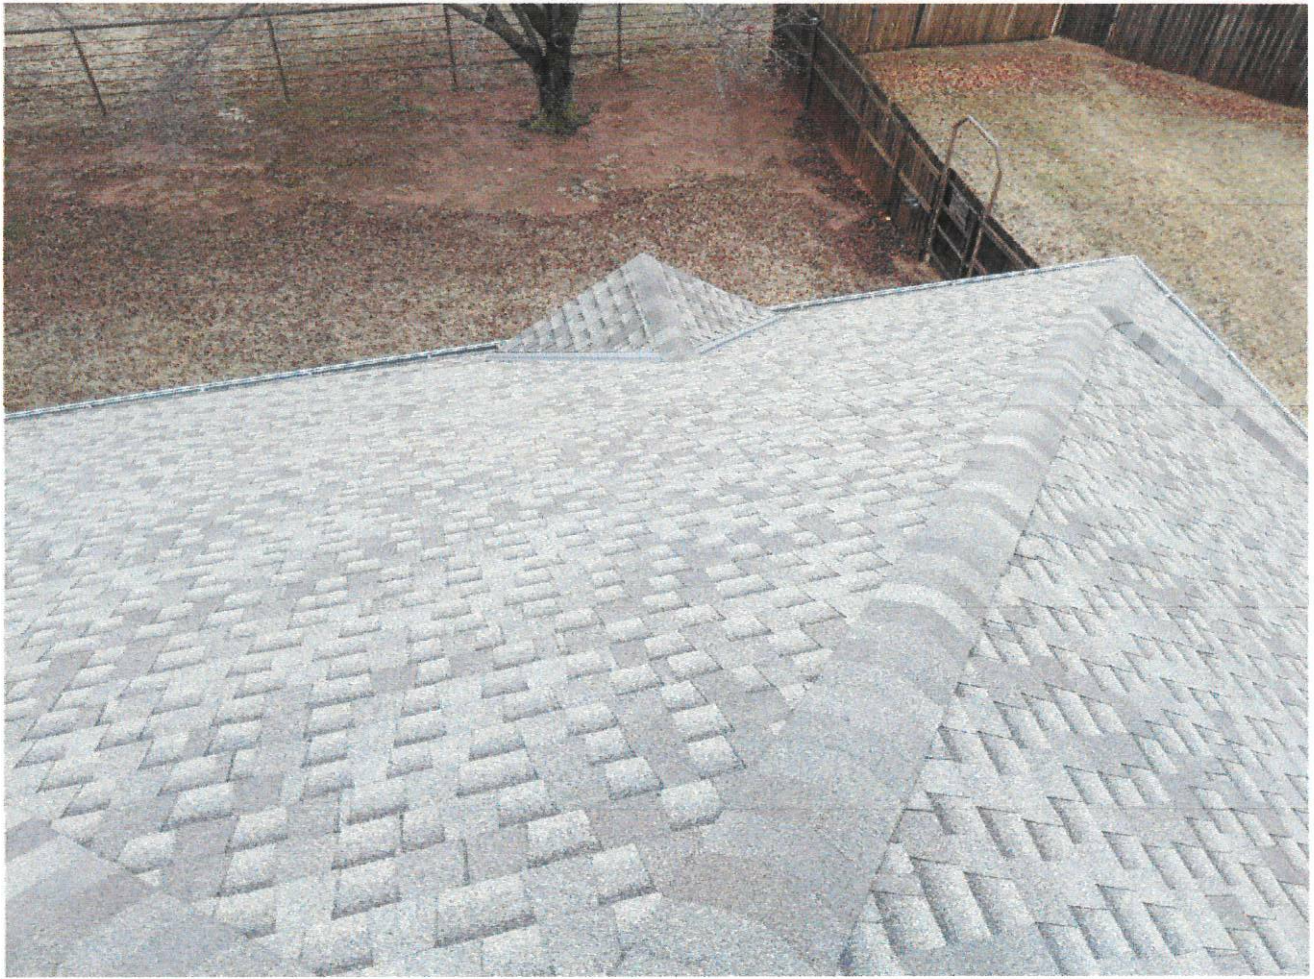
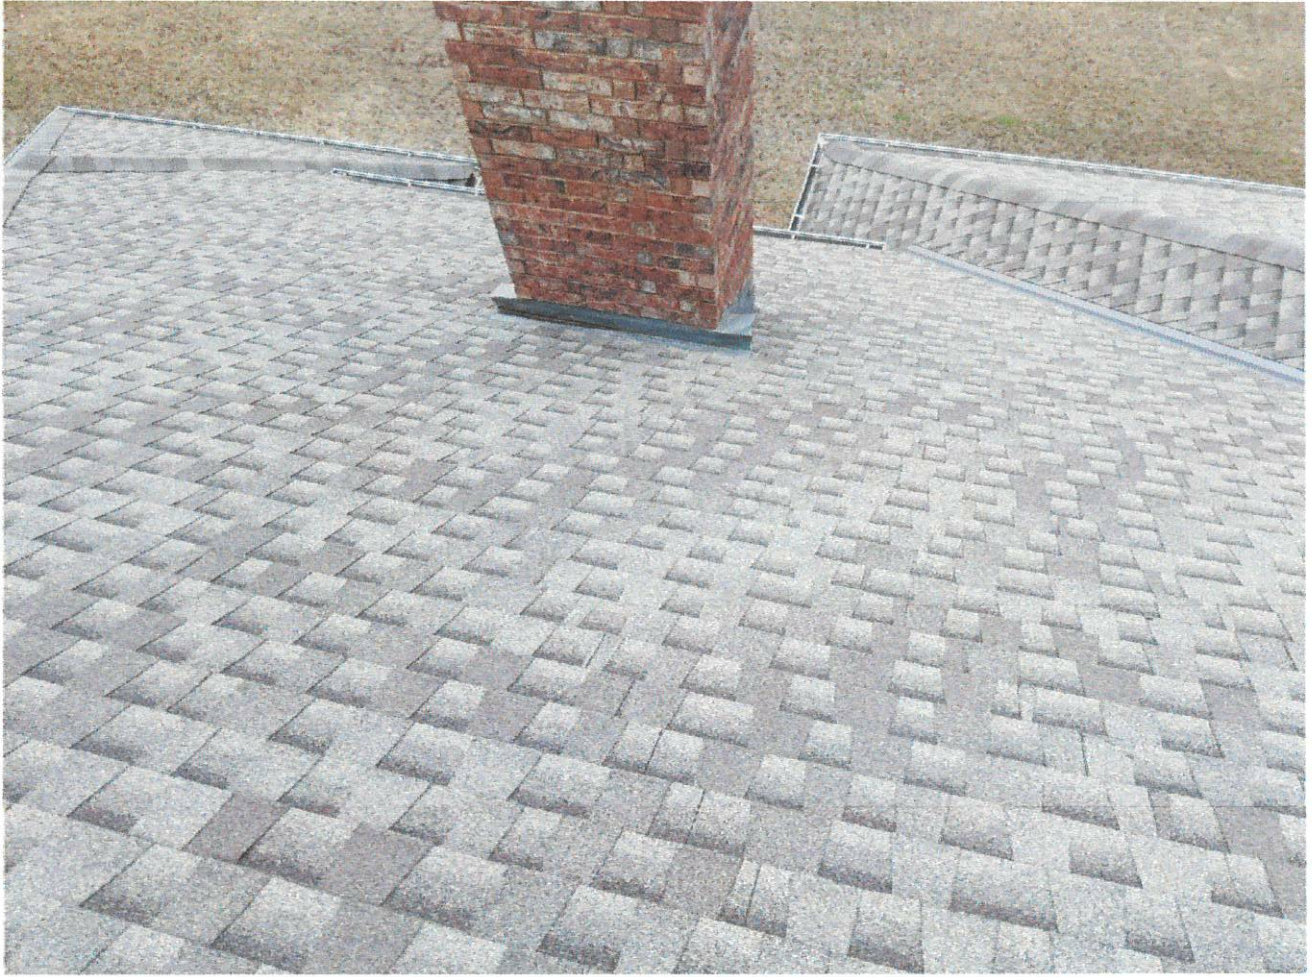
### **Roof Conditions**

#### **Typical Wear**

Roof is displaying signs of typical wear and/or some surface damage. An inspectors job is not to determine if roof is insurable or to what degree. Buyer is responsible for securing terms of insurance prior to close of transaction.

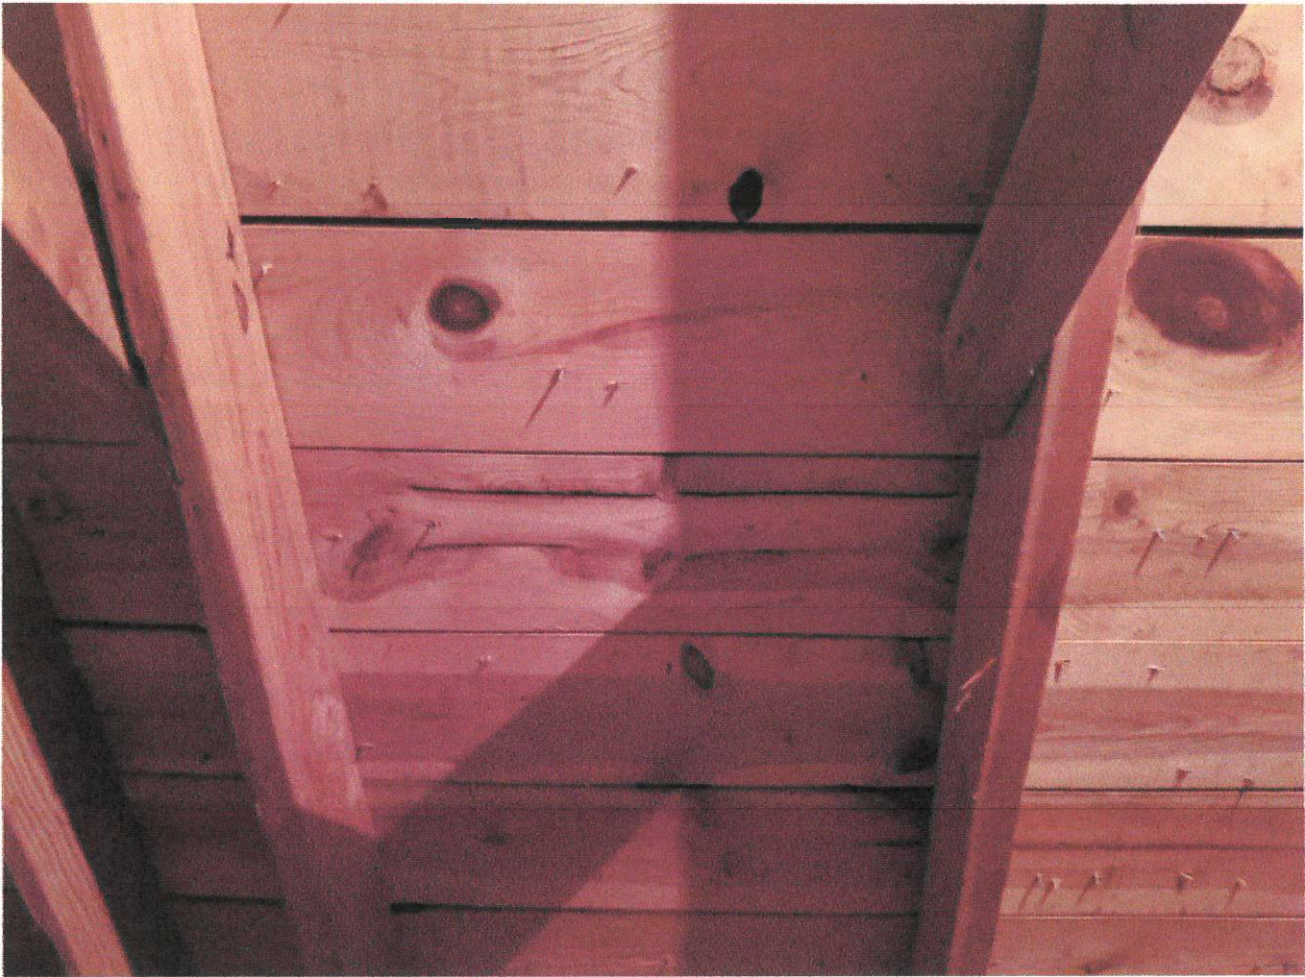
**Coverings: Roof decking**

The roof decking installed at time of inspection was board decking 1X 8 or greater this is no longer acceptable for asphalt shingles recommend replacement or covering with sheathing at next roof replacement.
