-   Inspection Details
-   Structure, Foundation, Crawl Space, & Basement
-

## 1 - Inspection Details

## 2 - Structure, Foundation, Crawl Space, & Basement

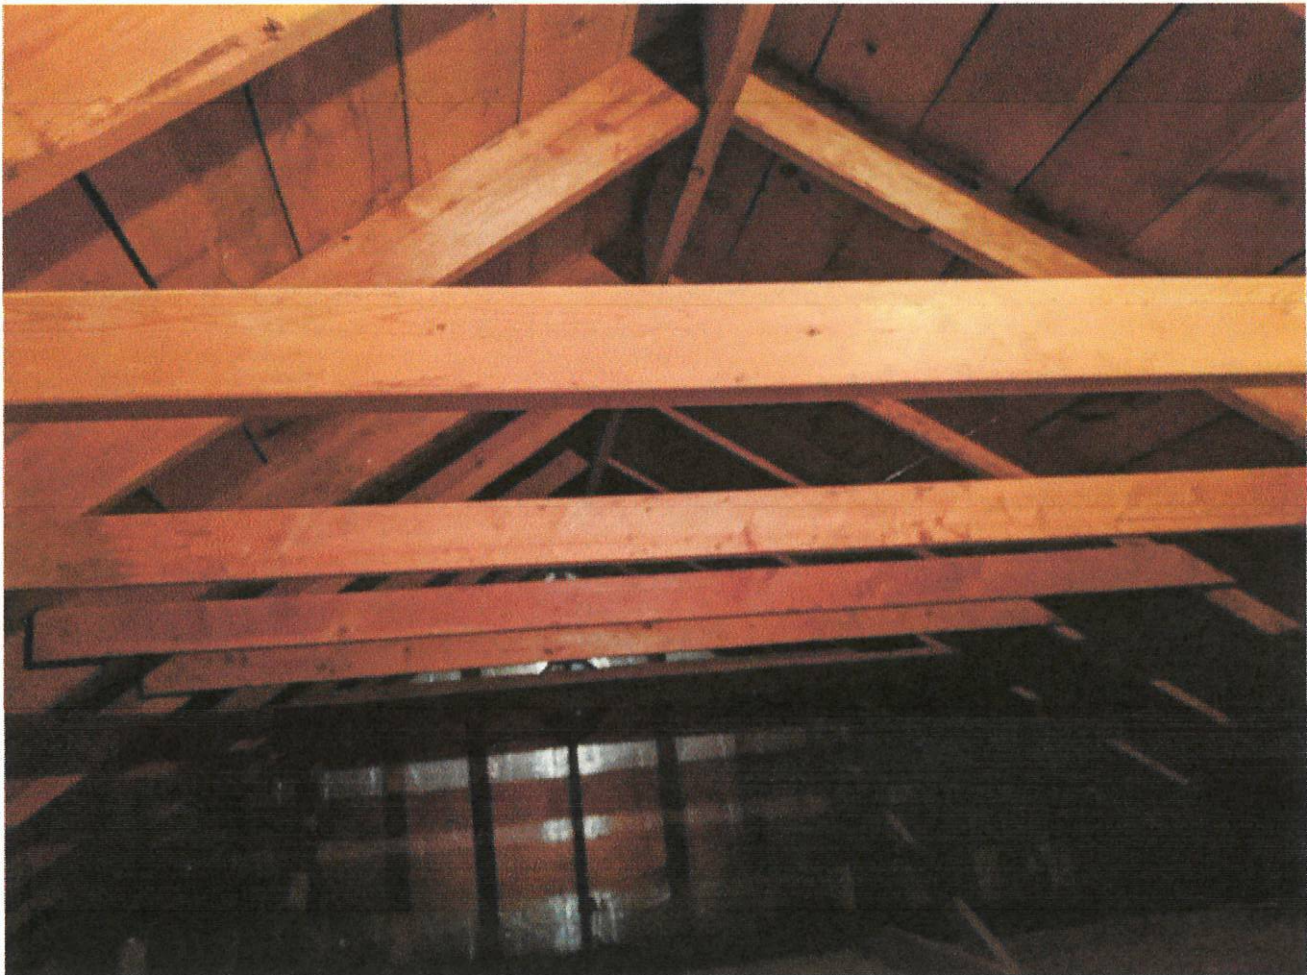
**Attic Structure: Framing Type**

Rafter Framing

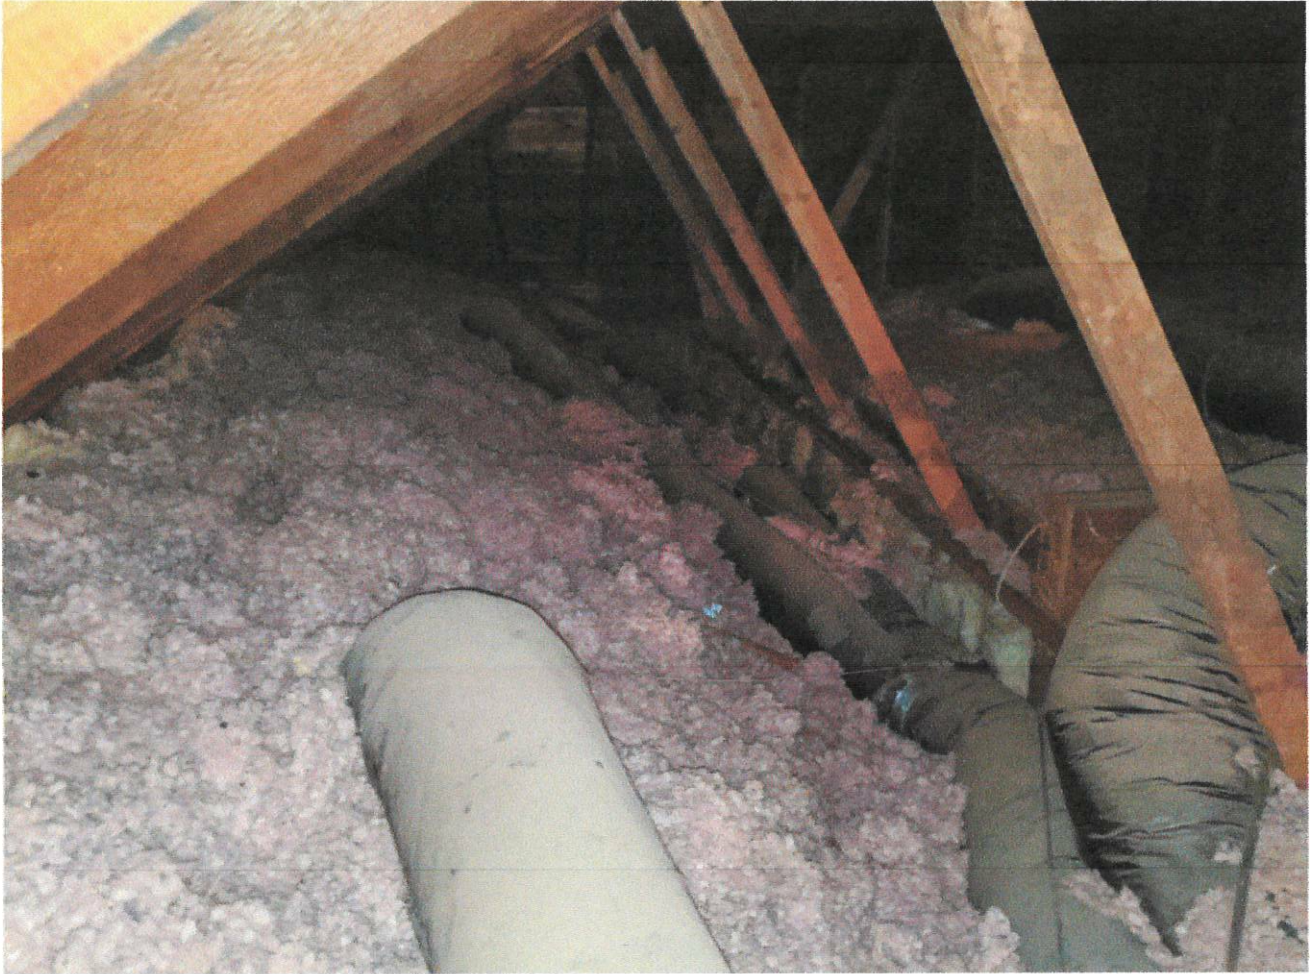
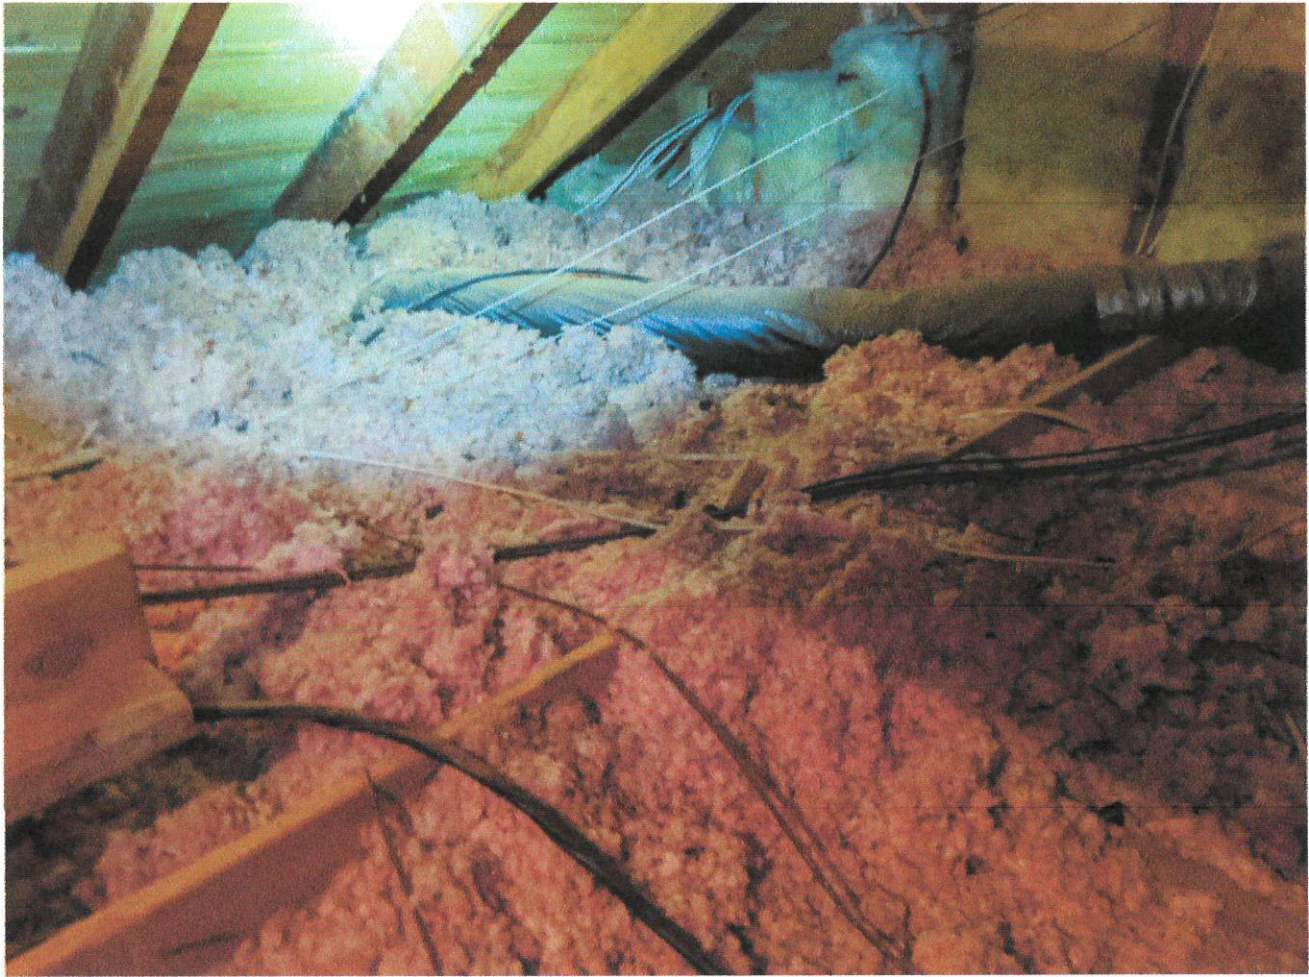
**Attic Insulation: Insulation Type**  
**Blown, Fiberglass**

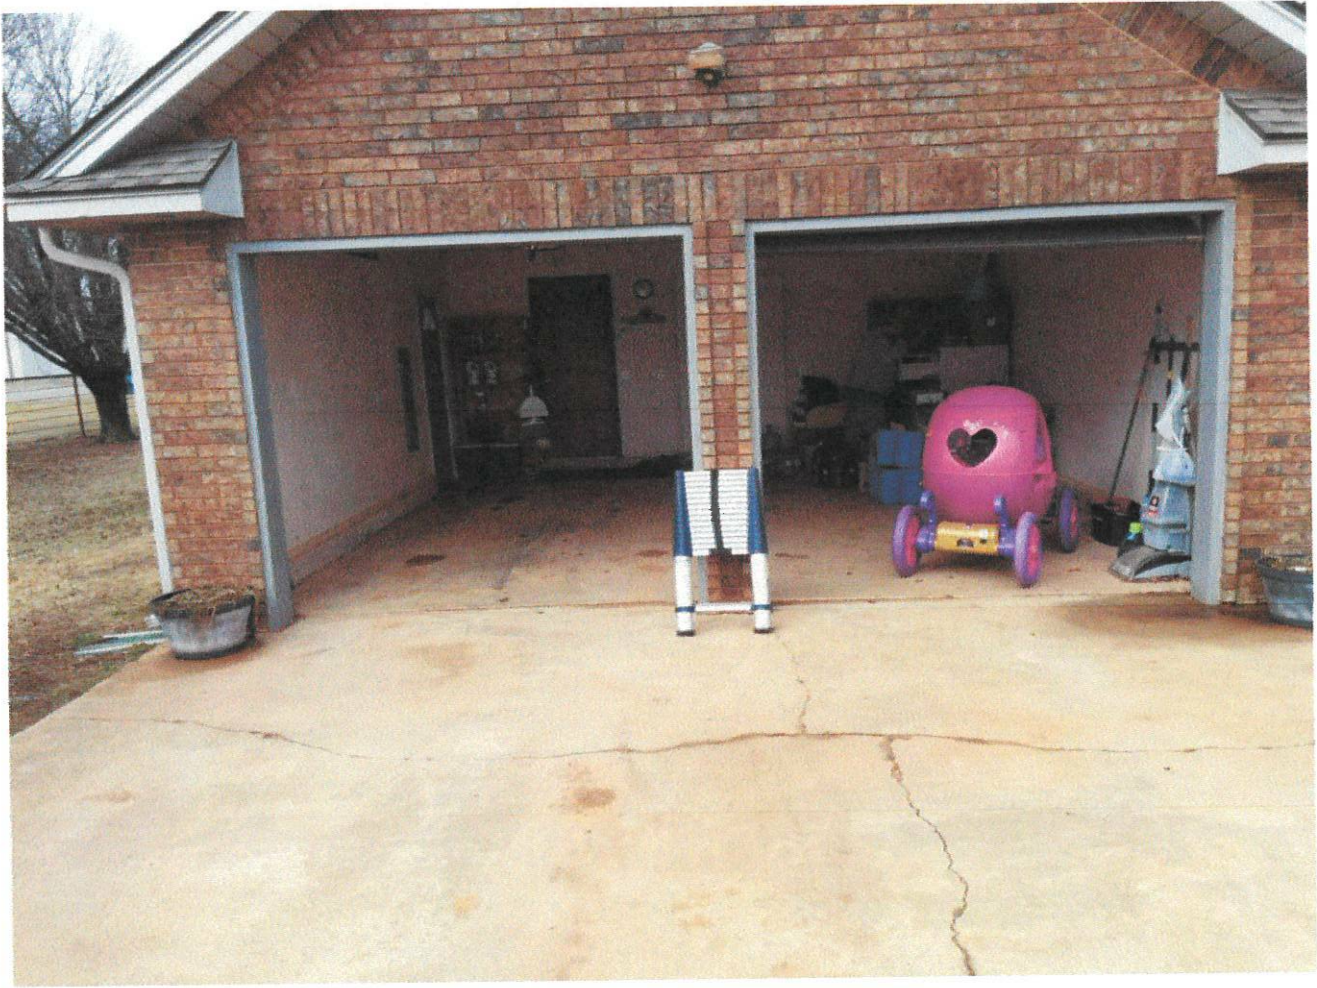
**Ceiling: Typical Cracks**

Typical cracks noted in garage ceiling.

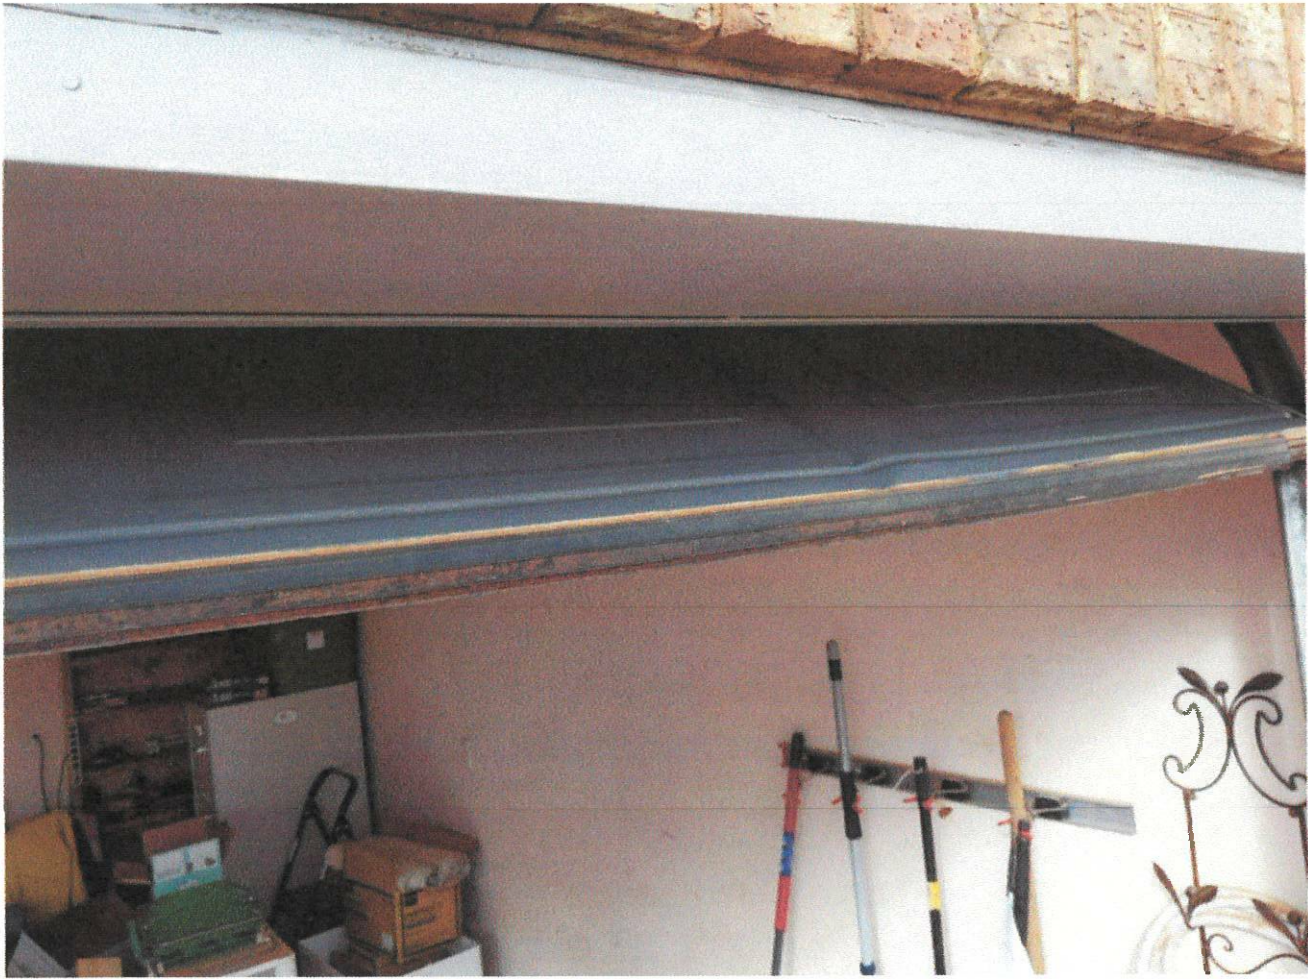
**Garage Door: Garage door damage**

Damage was viewed at the garage door panels, the door did operate as it was intended to at time of inspection.

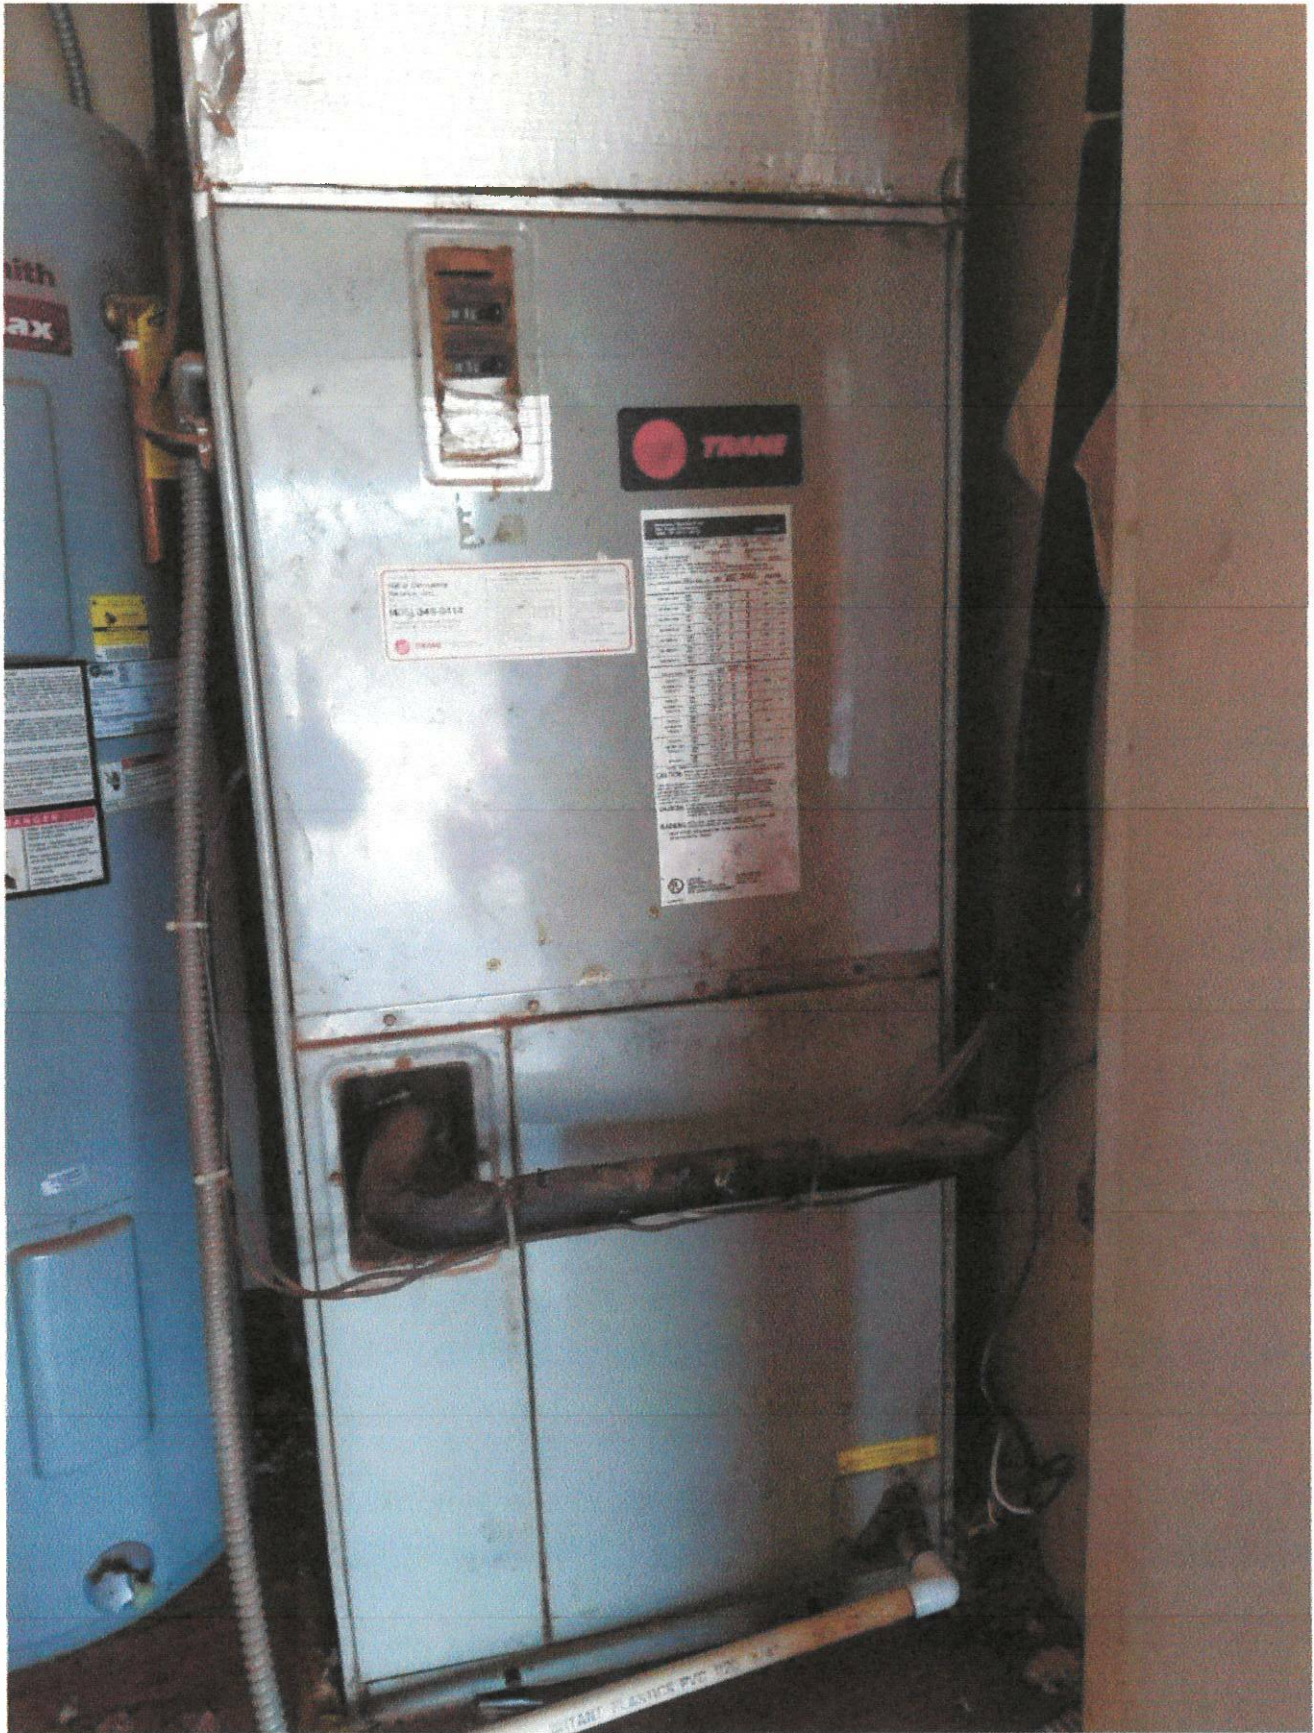
**Heating Equipment: Brand**

The unit is a ~~120~~ and 60/60 amp - New Comp. 2020  
2007

TWE048C140B3    K02870897    1/2    4.2    200-230    1PH  
MODEL NO.    SERIAL NO.    MOTOR H.P.    F.L.A.M.P.S.    VOLTS    PHASE

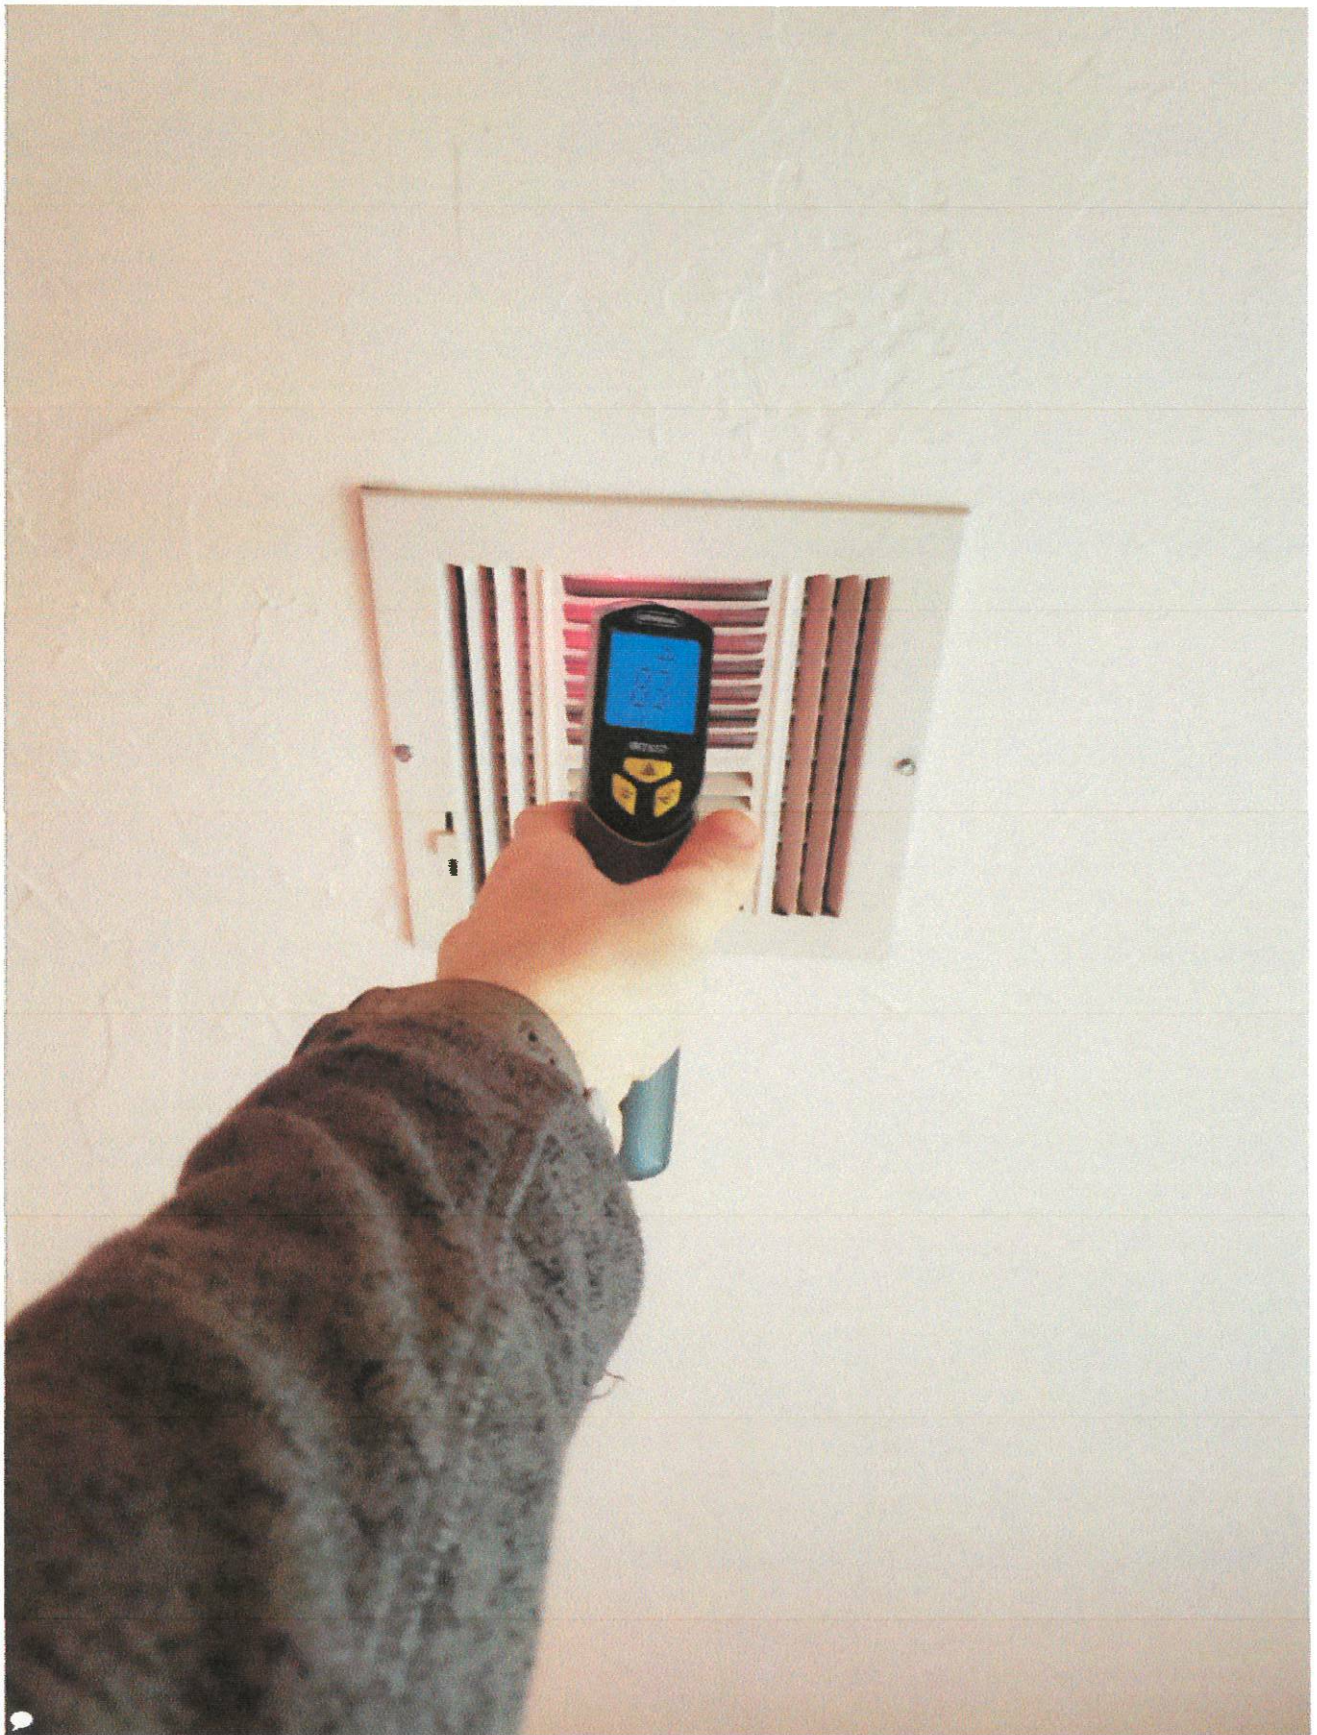
**Heating Equipment: Supply vent on heating mode**

The heating temperatures on emergency heat mode were below average, and temperatures outside were too low to test the heat pump. Recommend a qualified contractor clean and evaluate for proper function

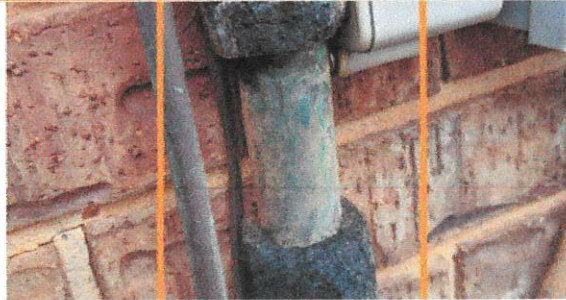
7.1.1 - Cooling Equipment

**INSULATION MISSING OR DAMAGED**

Missing or damaged insulation on refrigerant line can cause energy loss and condensation. Recommend repair as needed.

*Repaired*

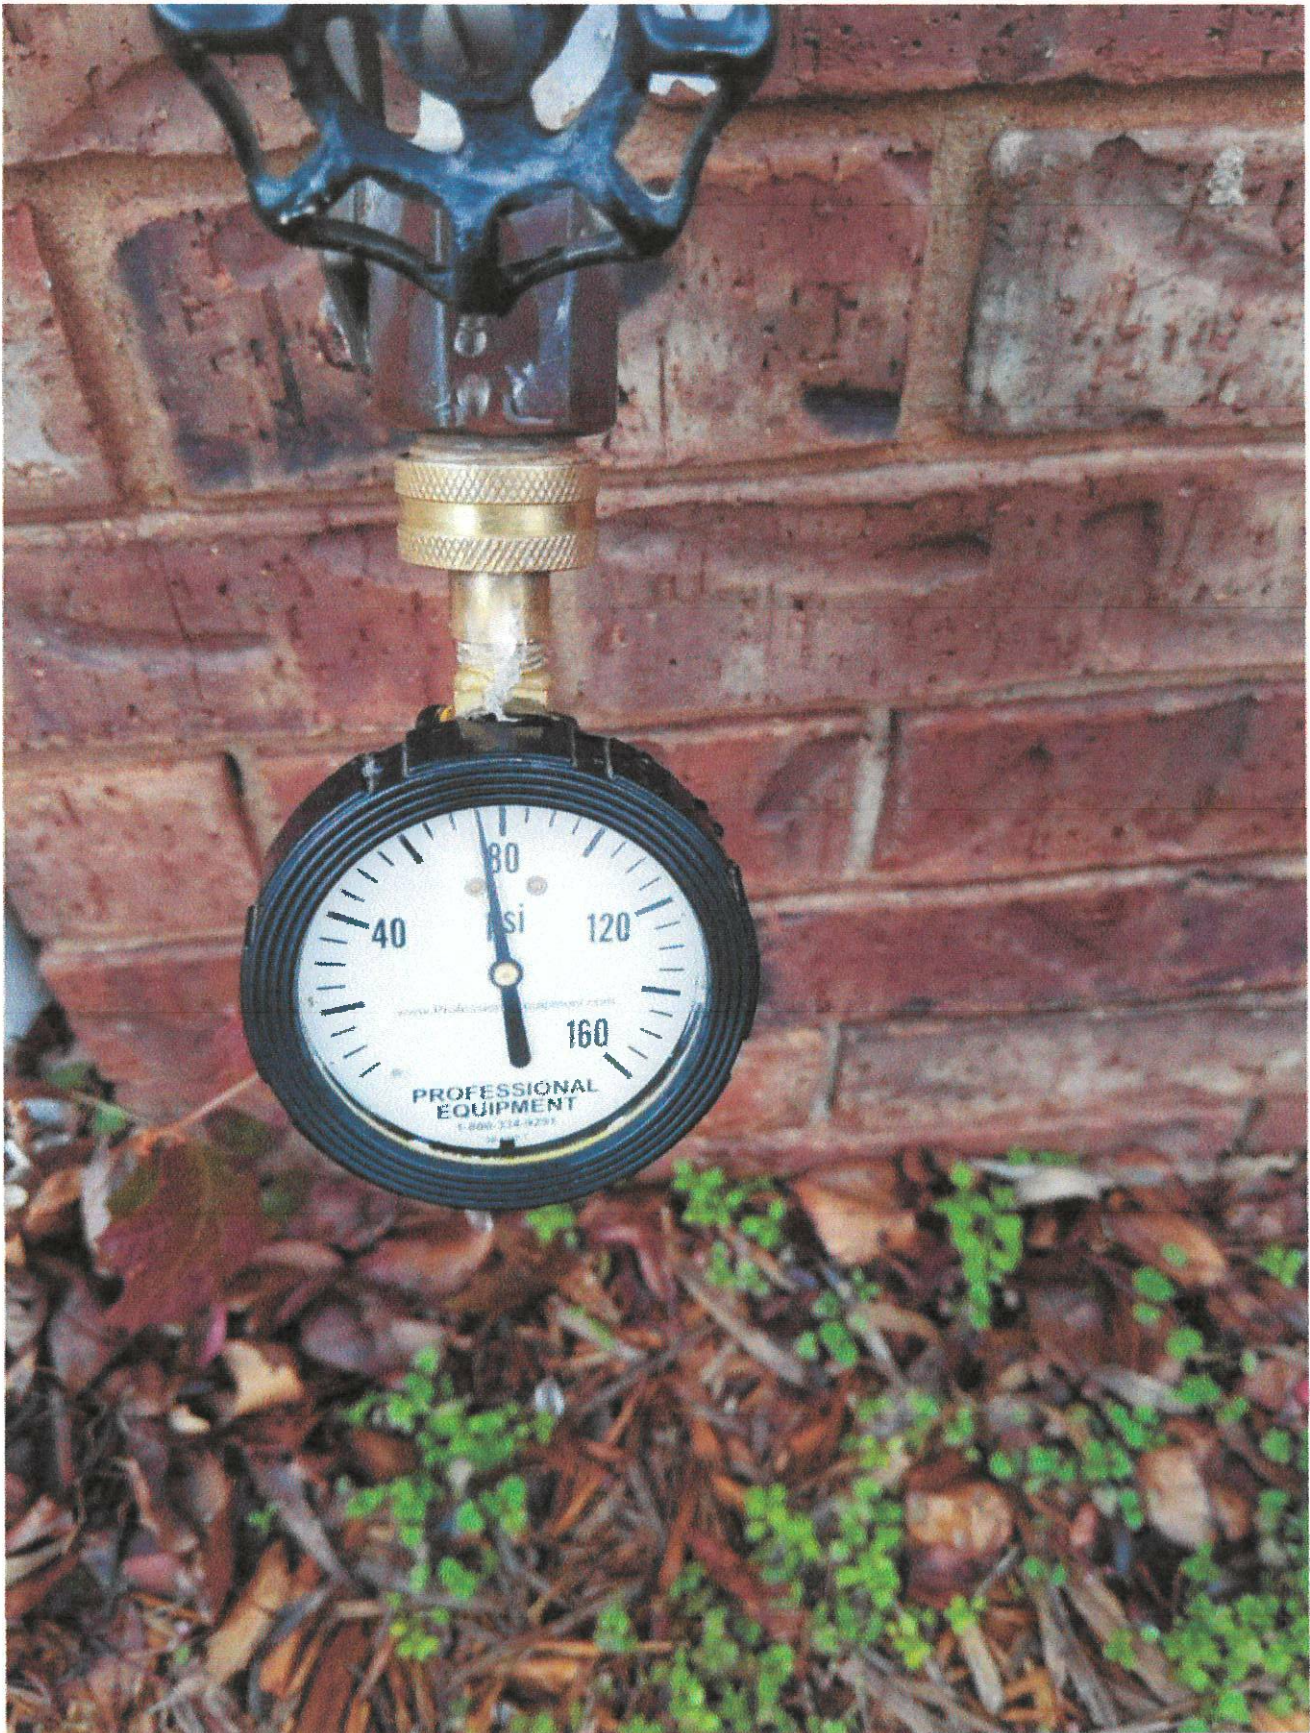
**Main Water Shut-off Device: Water pressure noted at exterior faucet.**

The water pressure was noted at the front outside faucet.

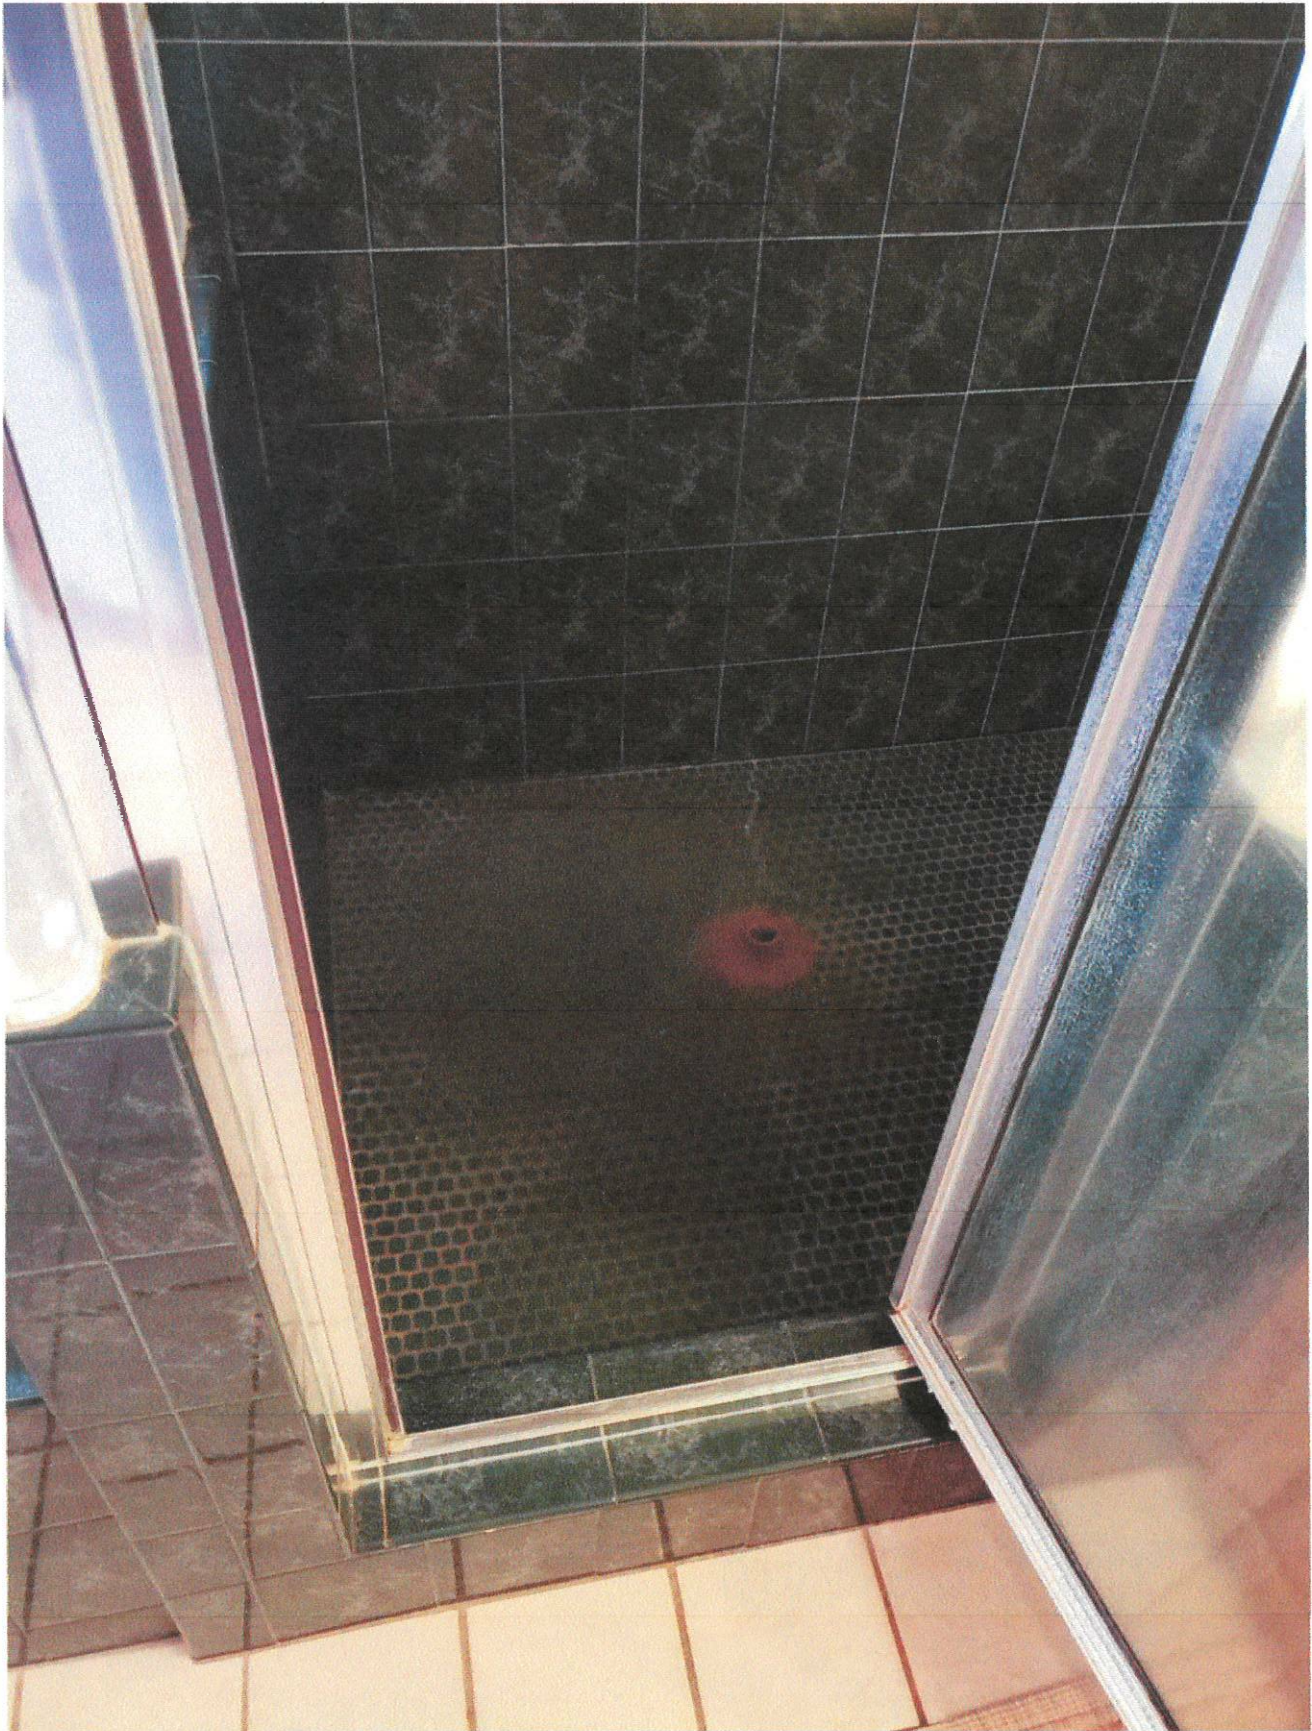
**Supply, Distribution & Fixtures: Shower pan test**

The shower pans were filled and no leaks viewed at time of inspection.

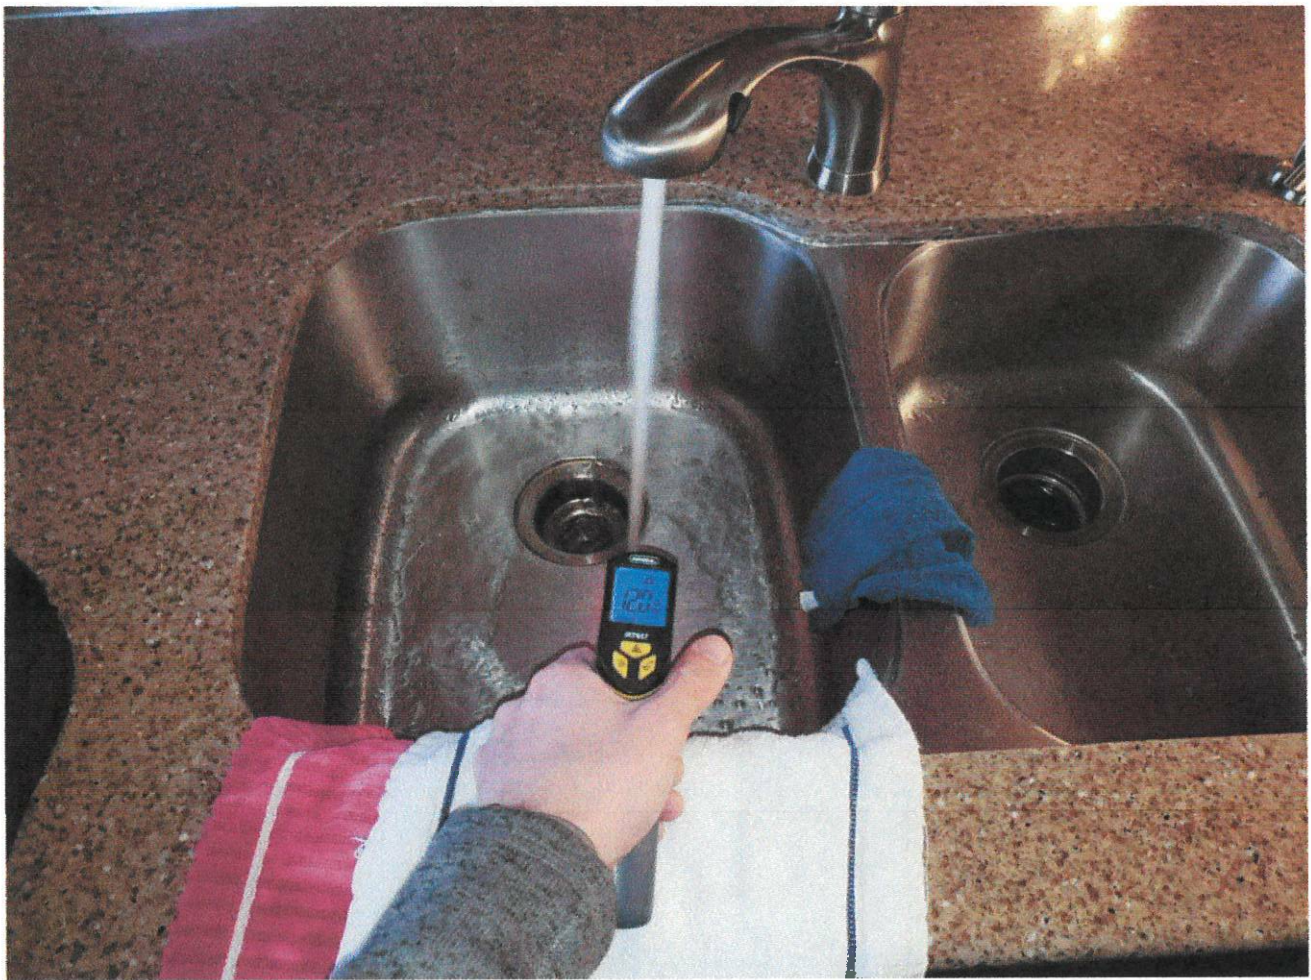
**Water heater: Hot Water Temperature**  
Acceptable range of 100-120 degrees Fahrenheit

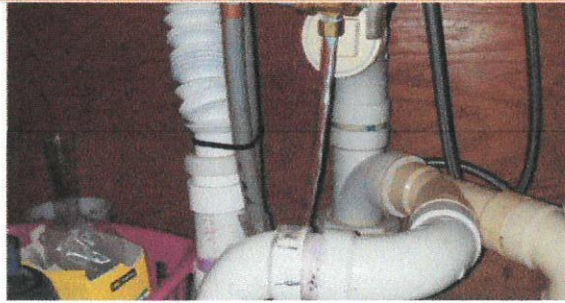
### 8.3.1 - Supply, Distribution & Fixtures

#### POLYBUTYLENE SUPPLY PIPES

Water supply pipes were made from polybutylene material. This material can be prone to fail without warning, causing damage to the home structure. Recommend a qualified plumber replace pipes and fittings with an approved material like PEX.

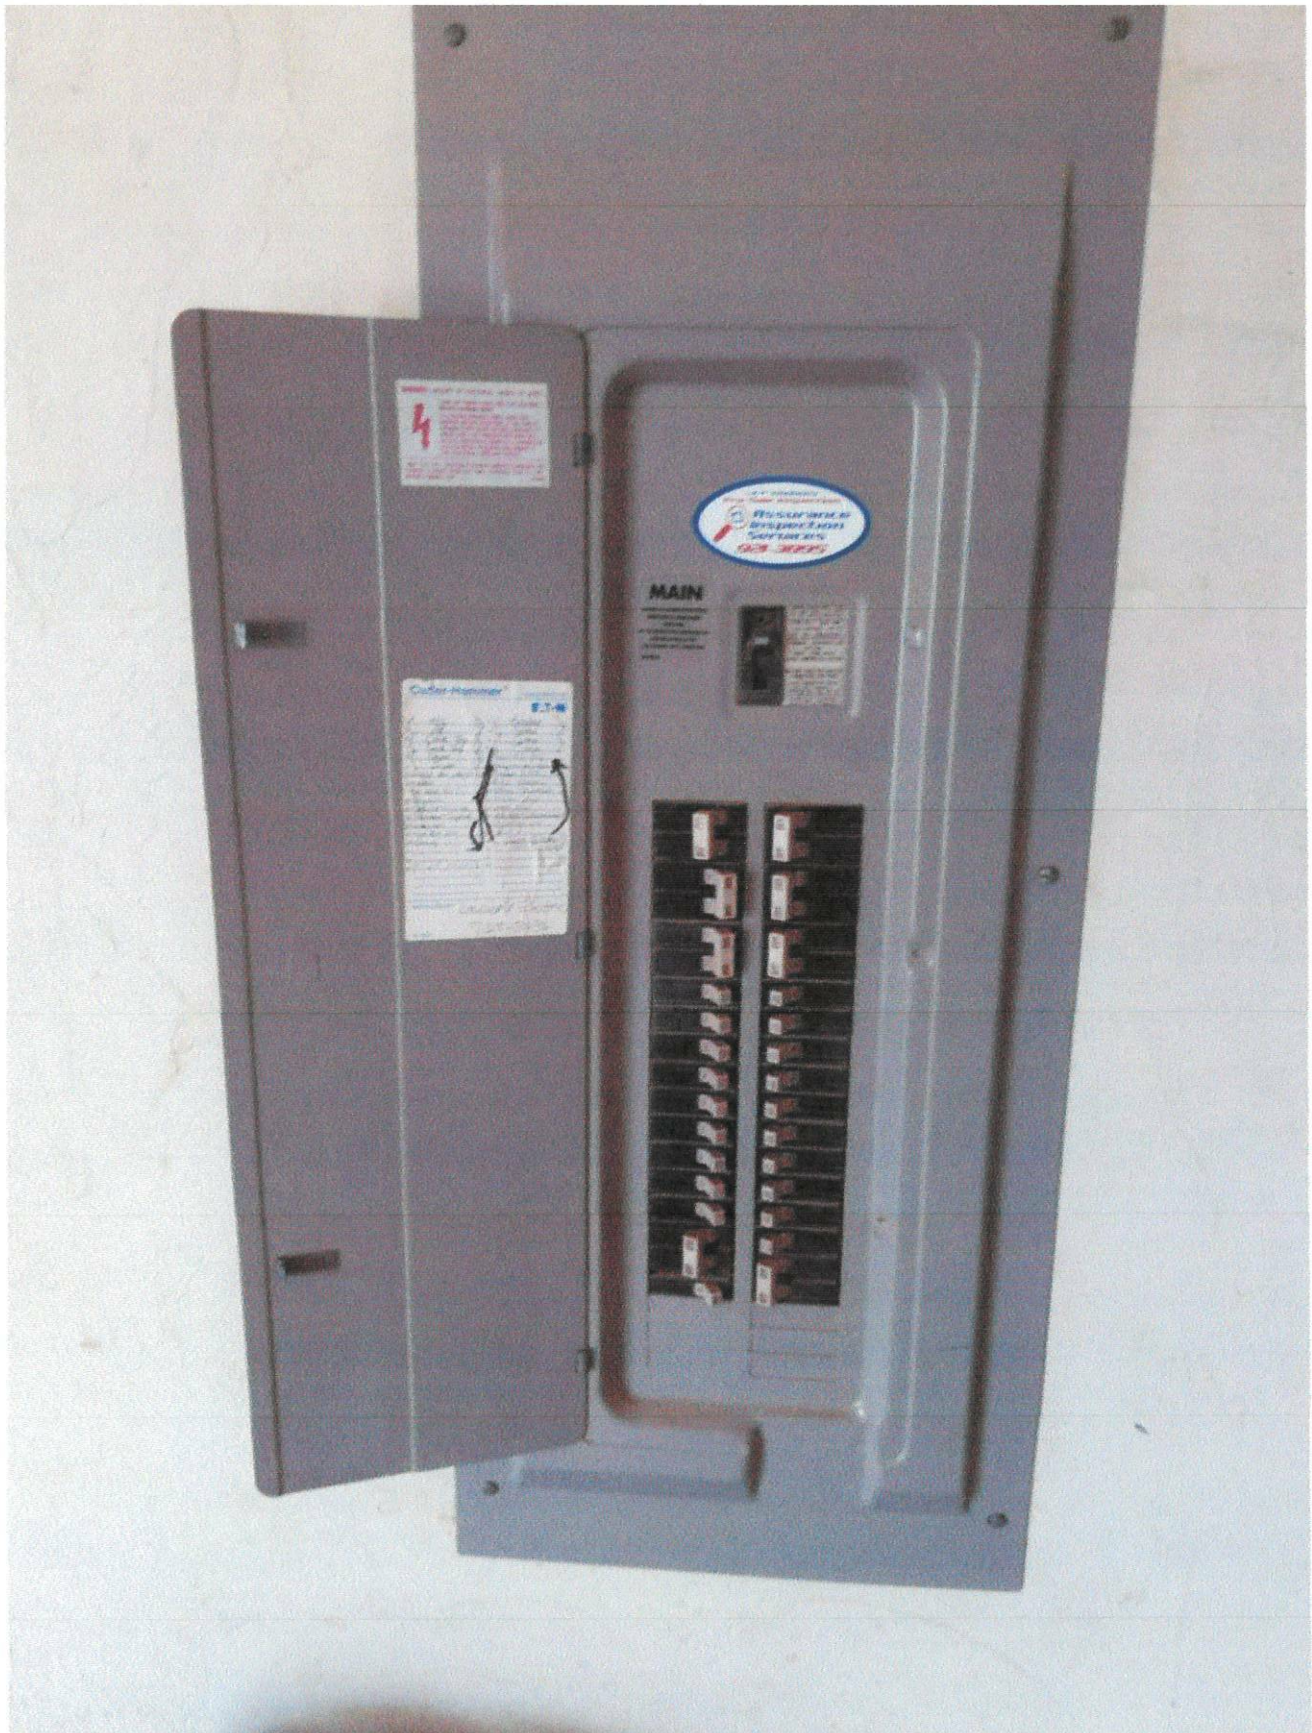
**Main & Subpanels, Service & Grounding, Main Overcurrent Device: The main panel inspection**

The main panel cover was removed and the interior inspected, we do not check for proper labeling of breakers, only if they are labeled.

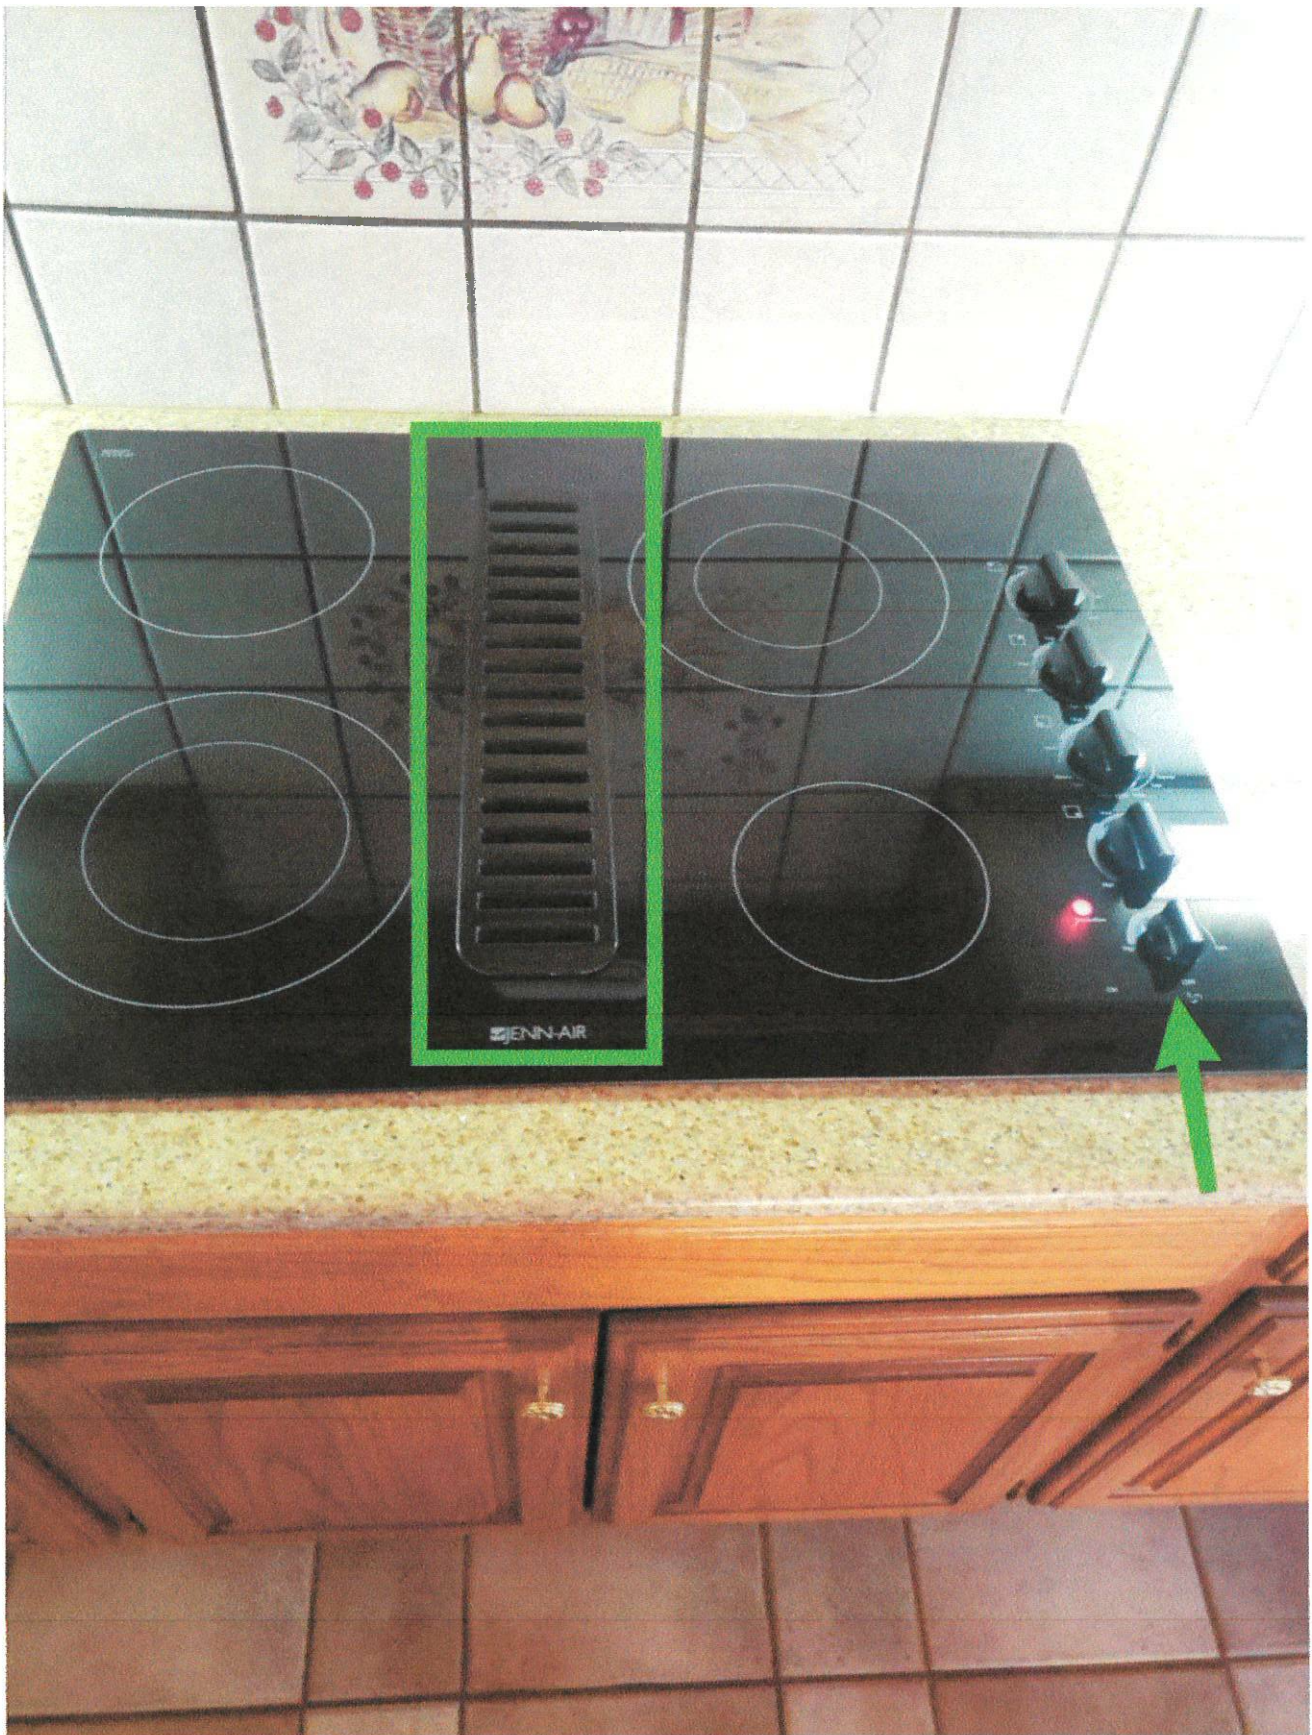
**Range/Oven/Cooktop: Kitchen Exhaust Fan**

Vents to Exterior
