-   Inspection Details
-   Structure, Foundation, Crawl Space, & Basement
-

## 1 - Inspection Details

## 2 - Structure, Foundation, Crawl Space, & Basement

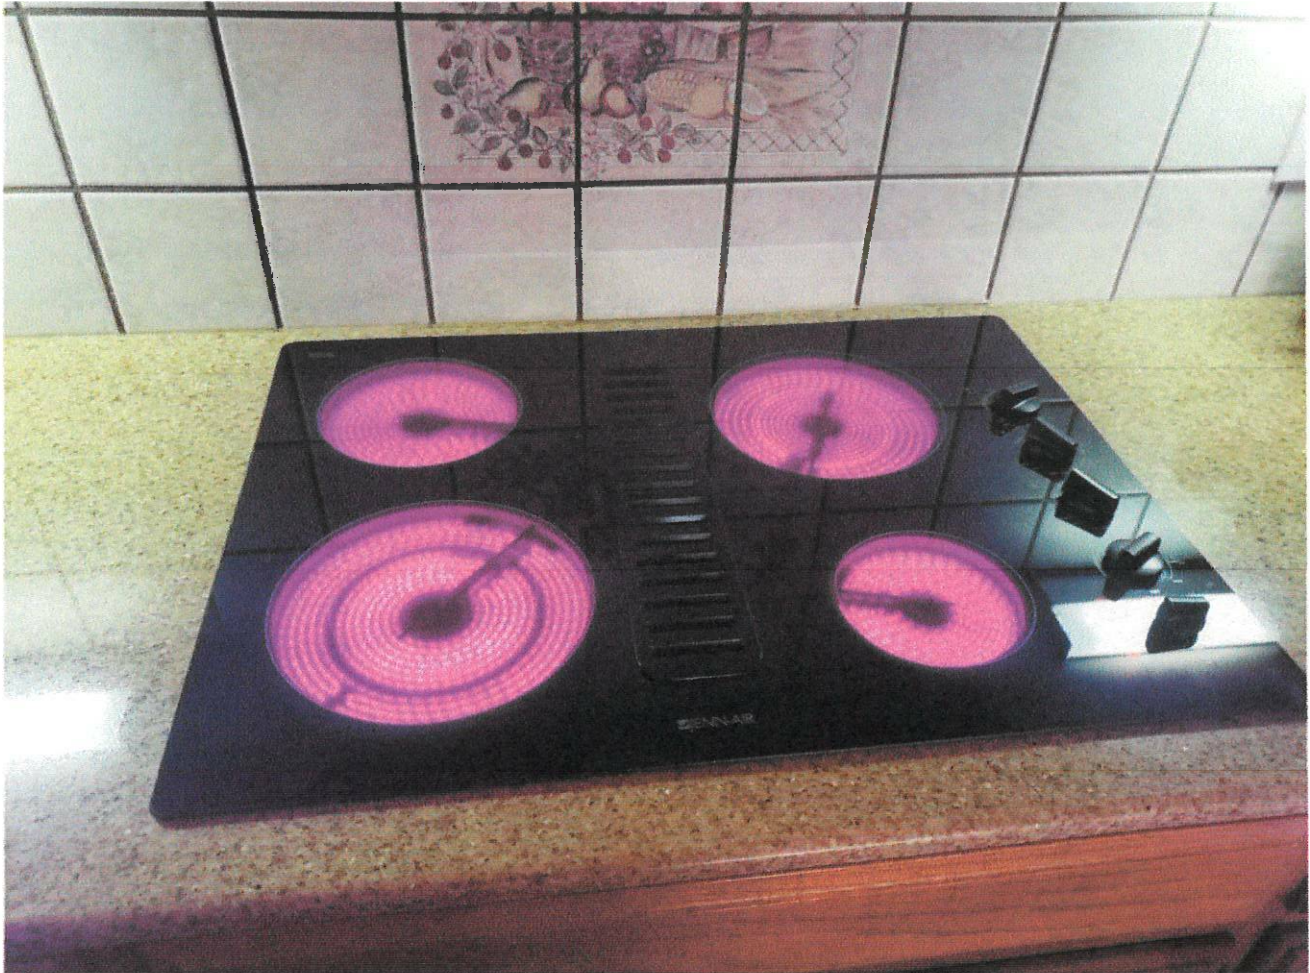
**Range/Oven/Cooktop: Range/Oven/Cook Top**  
**Cook Top, Glass Top**

Tested, and appears to be working as intended at the time of inspection. All modes were not tested.

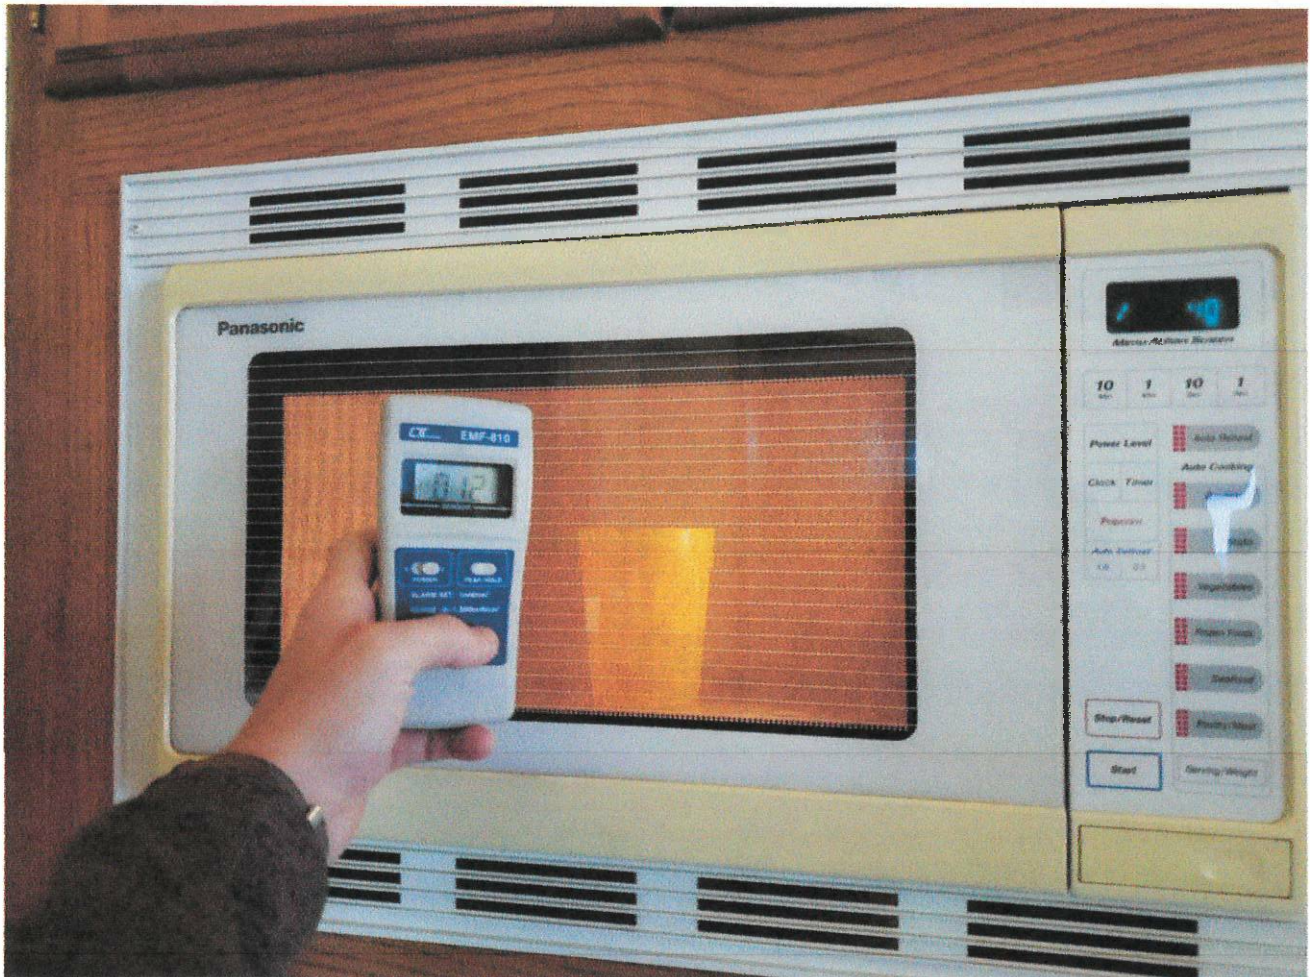
**Built-in Microwave: Built-In Microwave**  
Present

Tested, and appears to be working at the time of inspection. Abnormal noise was noted at the time of inspection. Recommend cleaning or adjustment as needed.

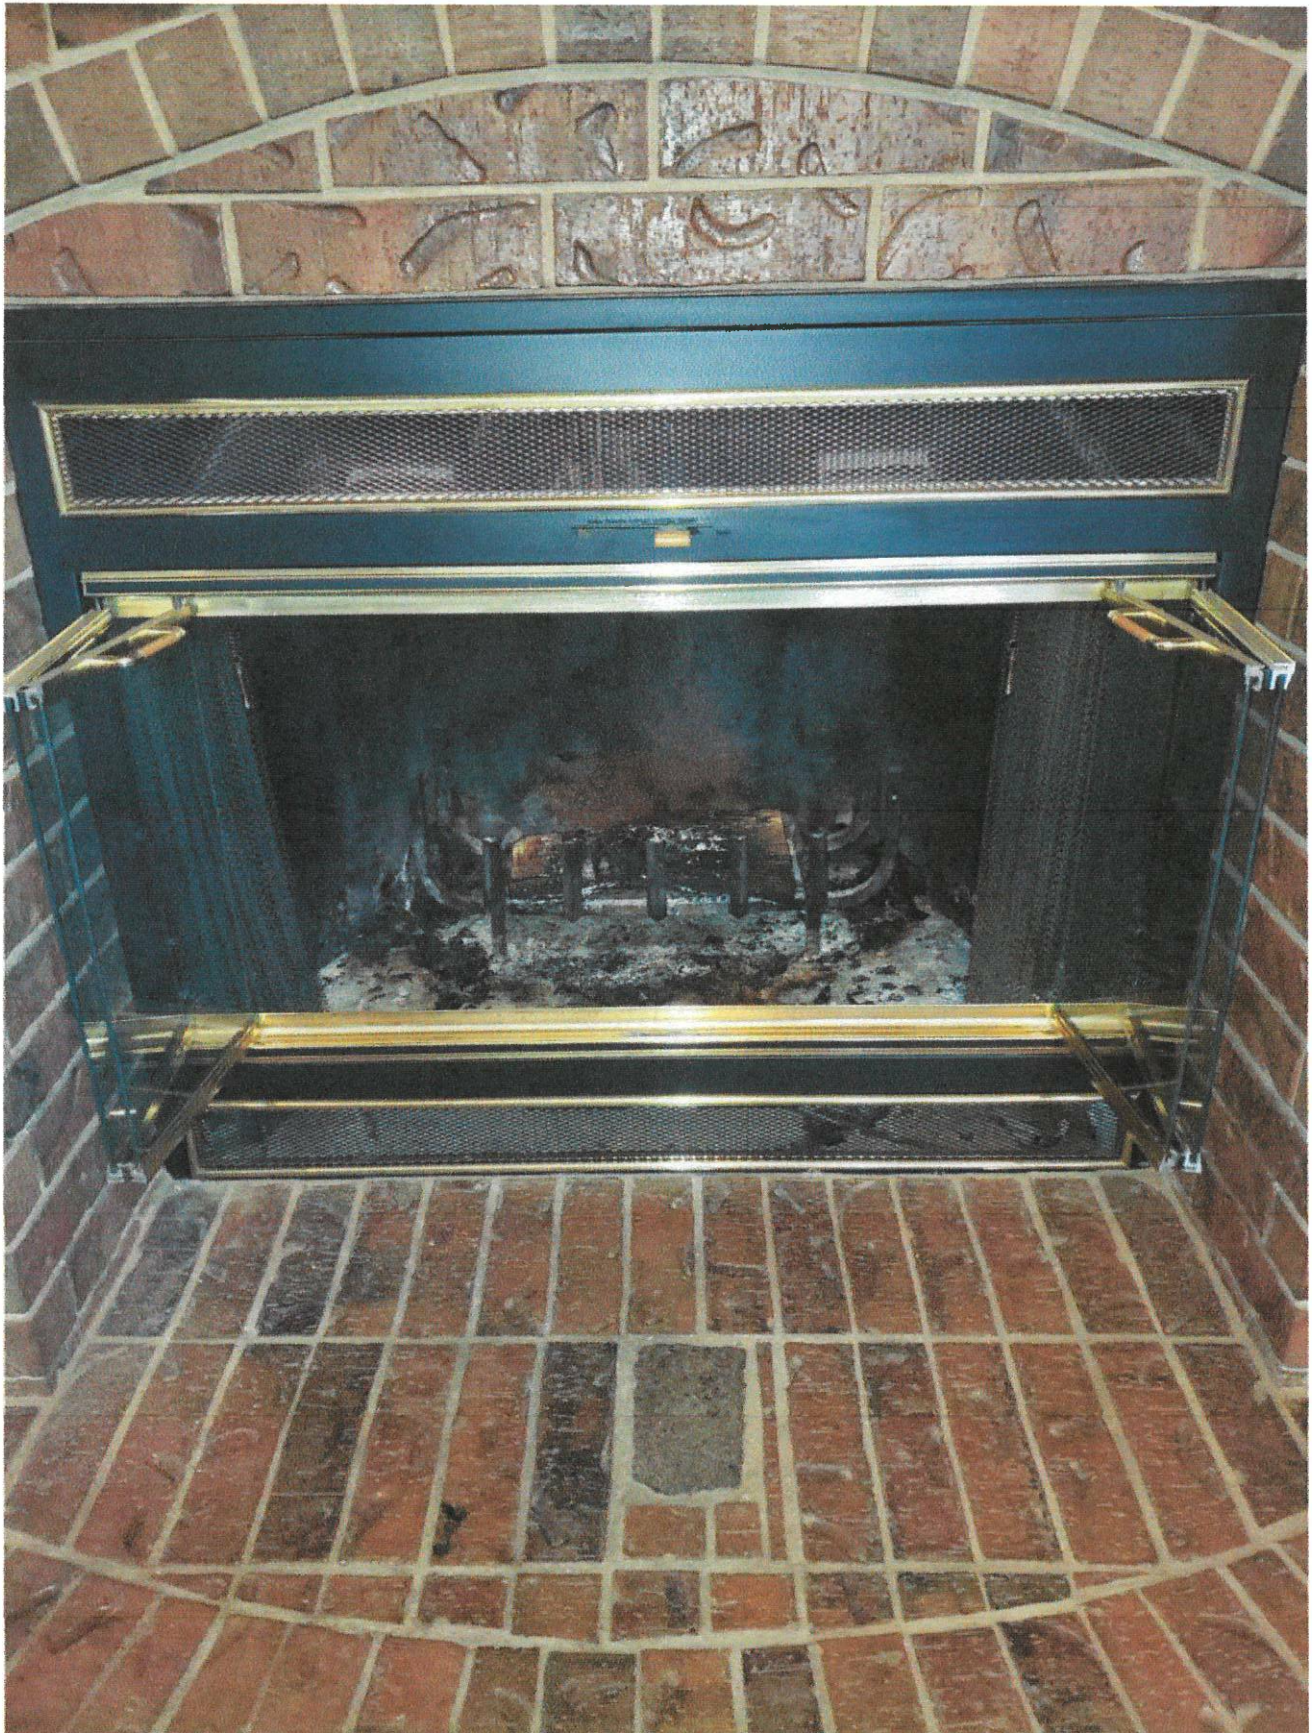
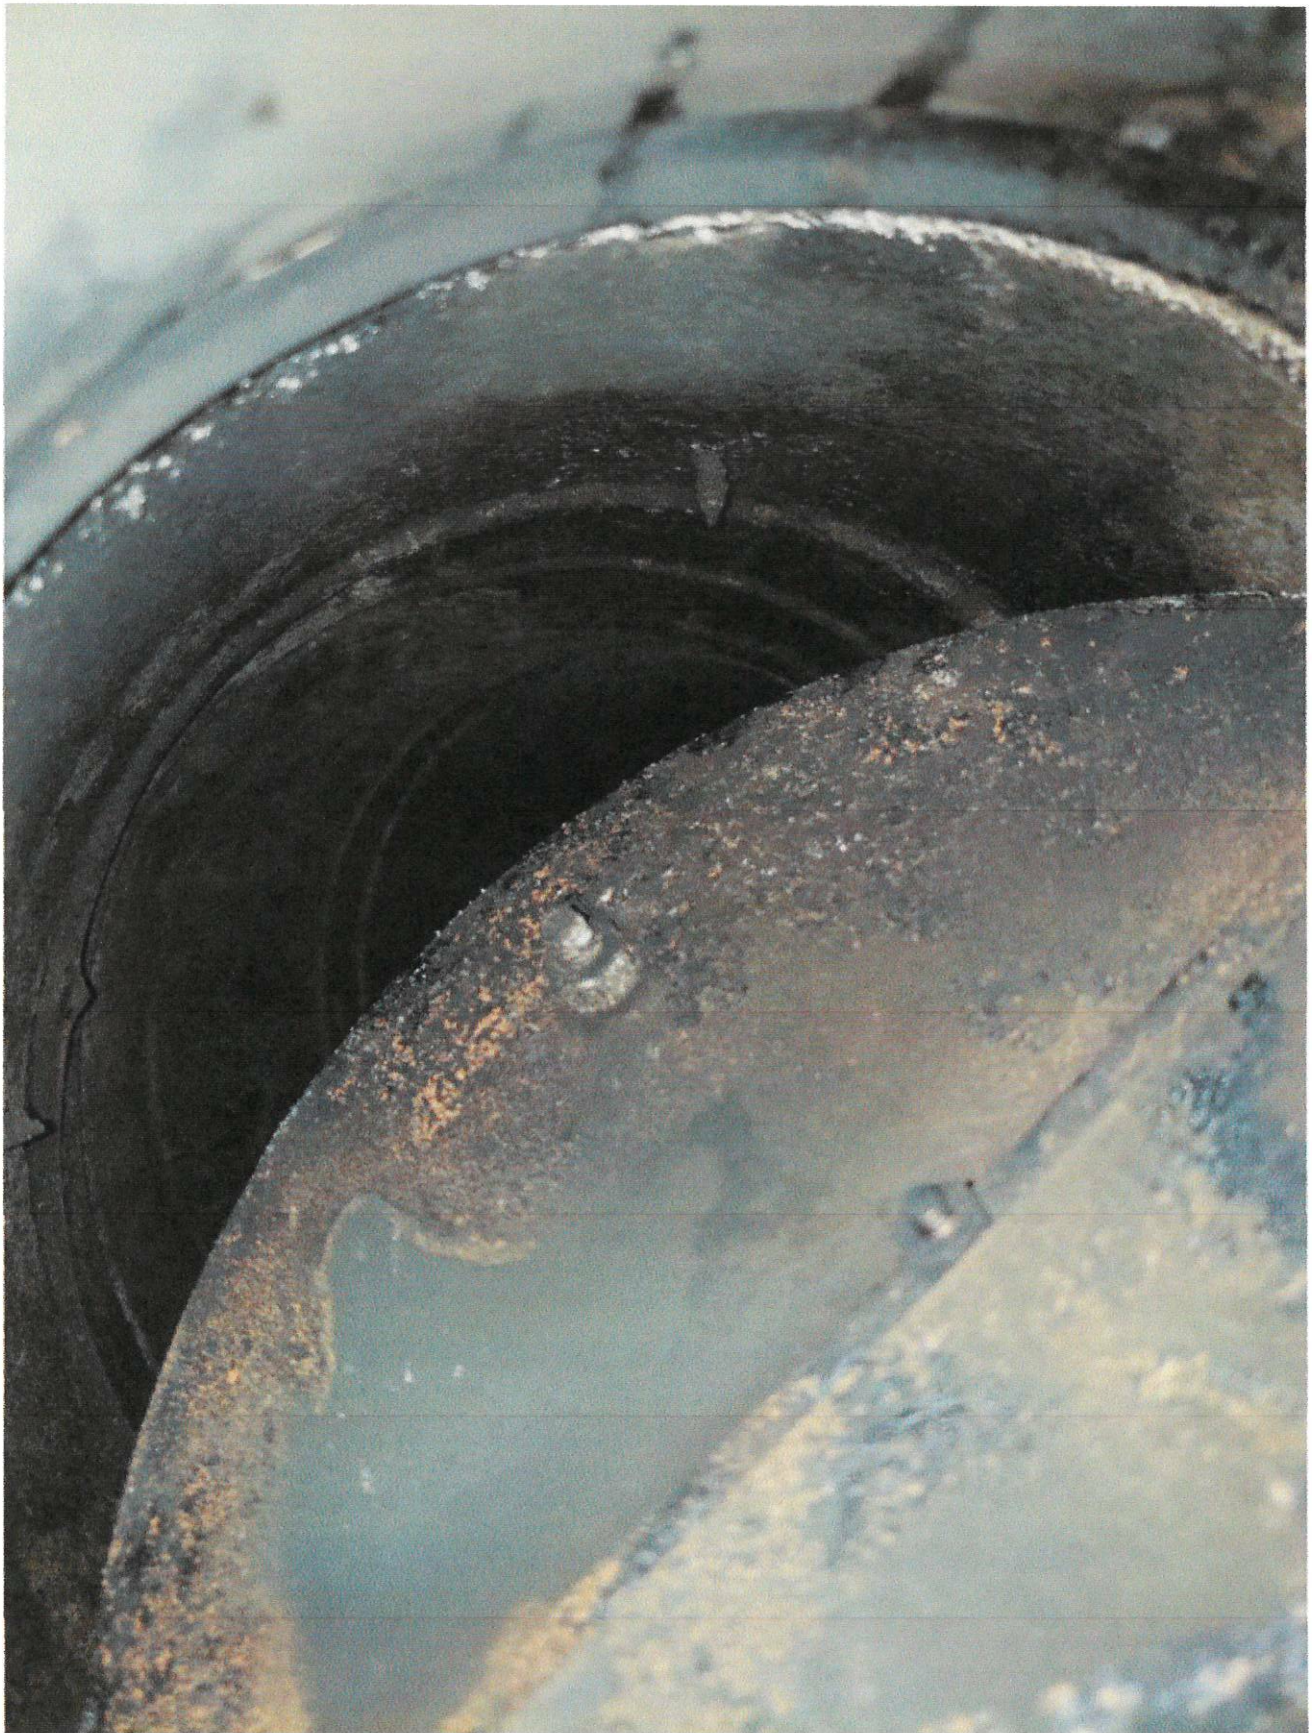
**Fireplace: No gas at fireplace**

This fireplace is not equipped with a gas starter unit. We recommend a thorough cleaning and inspection by a qualified chimney sweep before the first use.

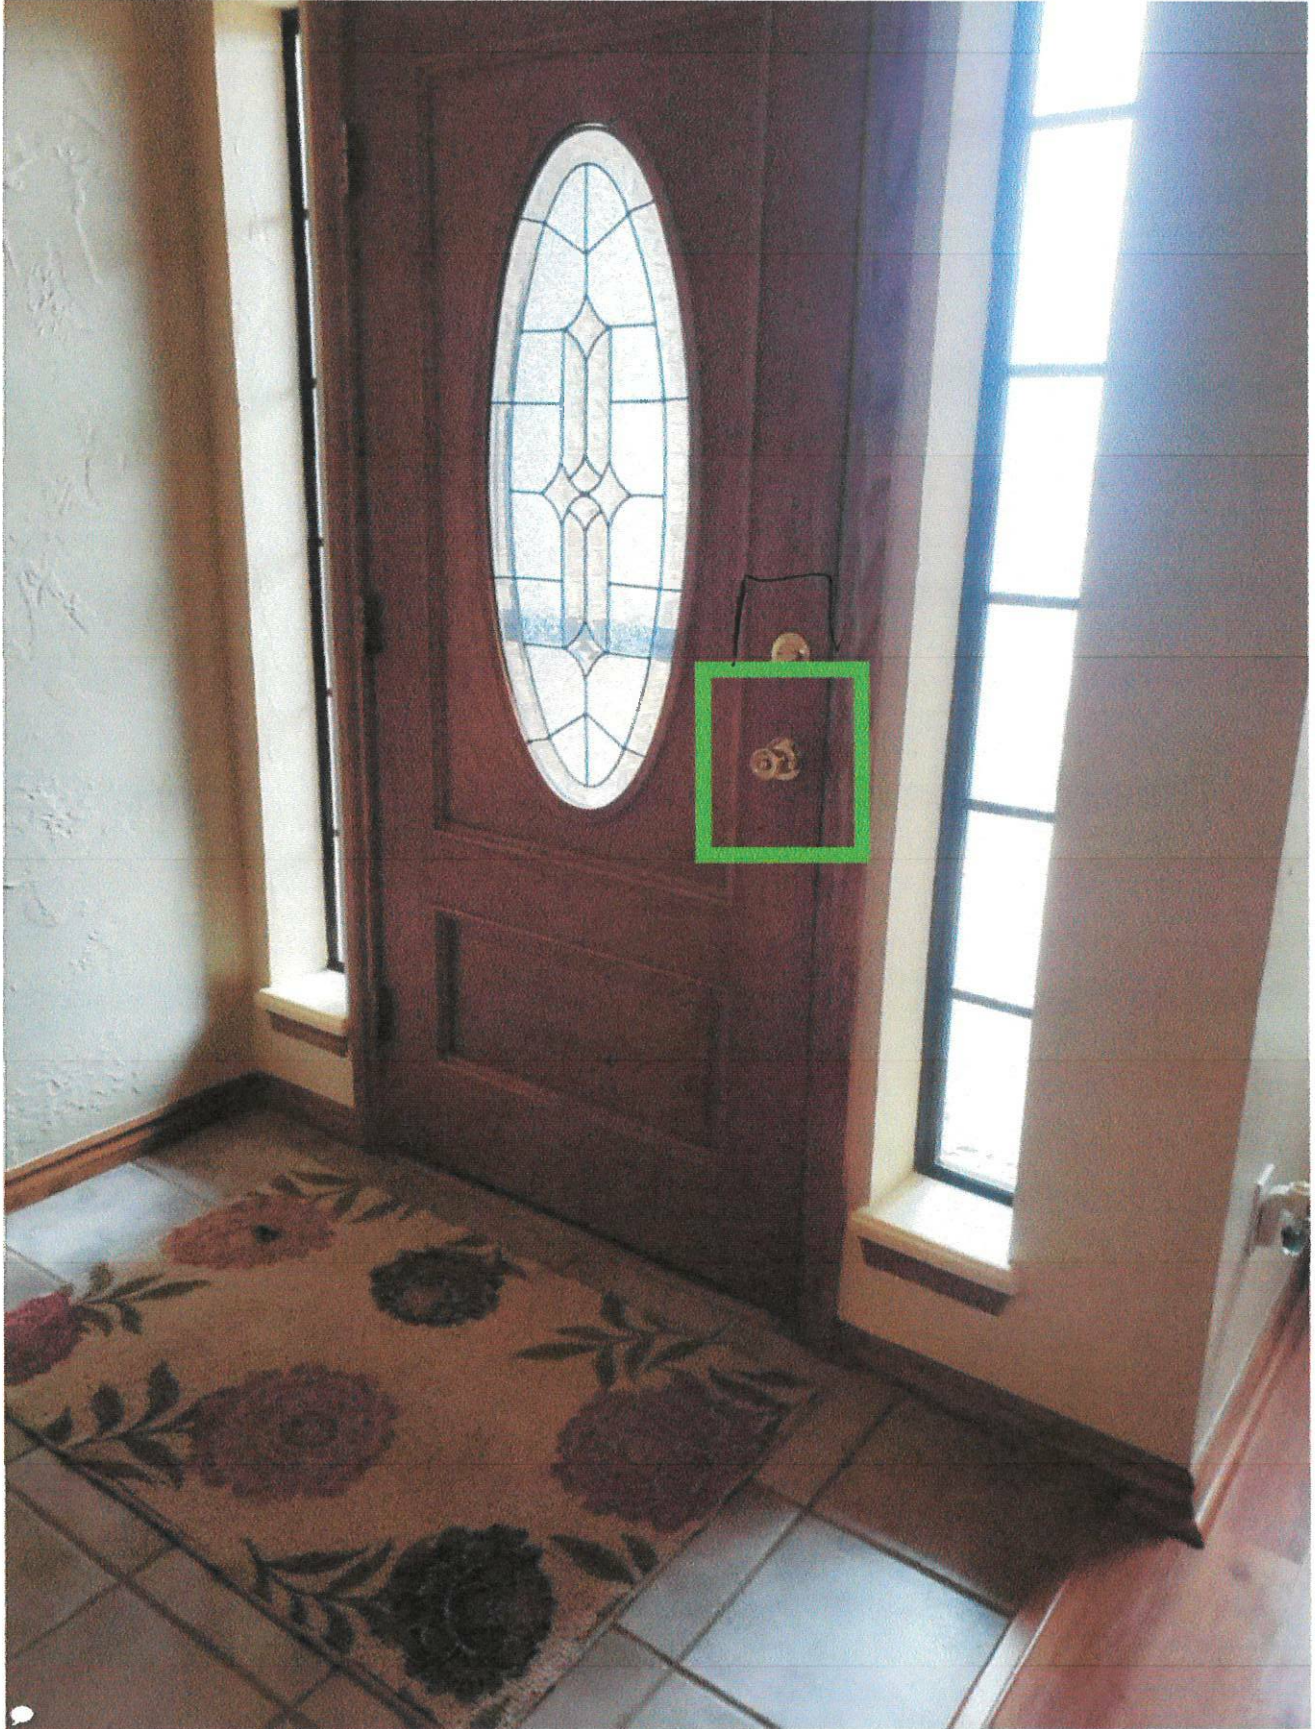
**Doors: Loose hardware**

Loose door hardware noted on various doors throughout home. Recommend adjustment as needed for proper operation and safety

Replaced

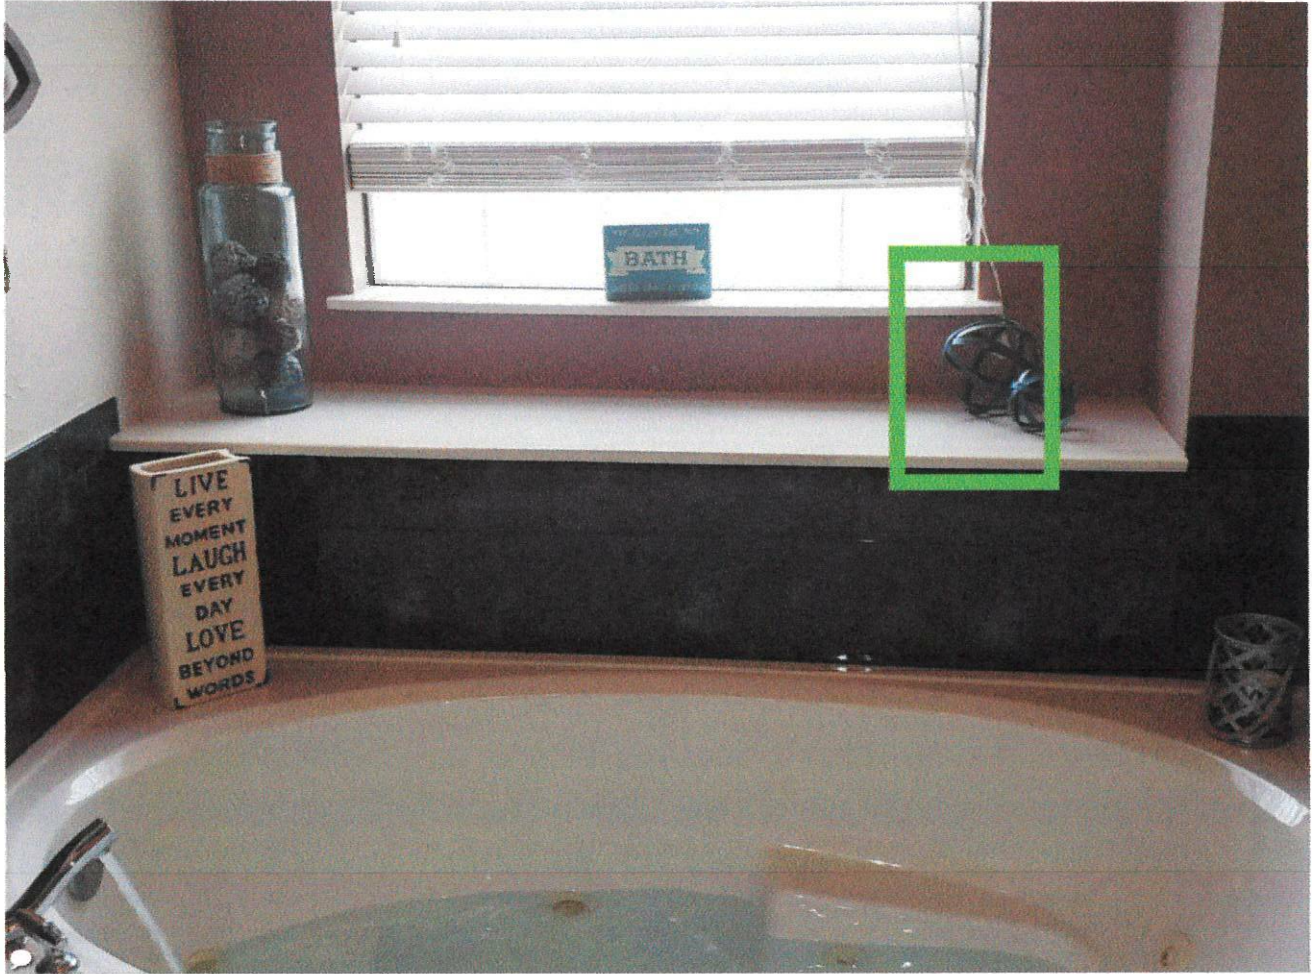
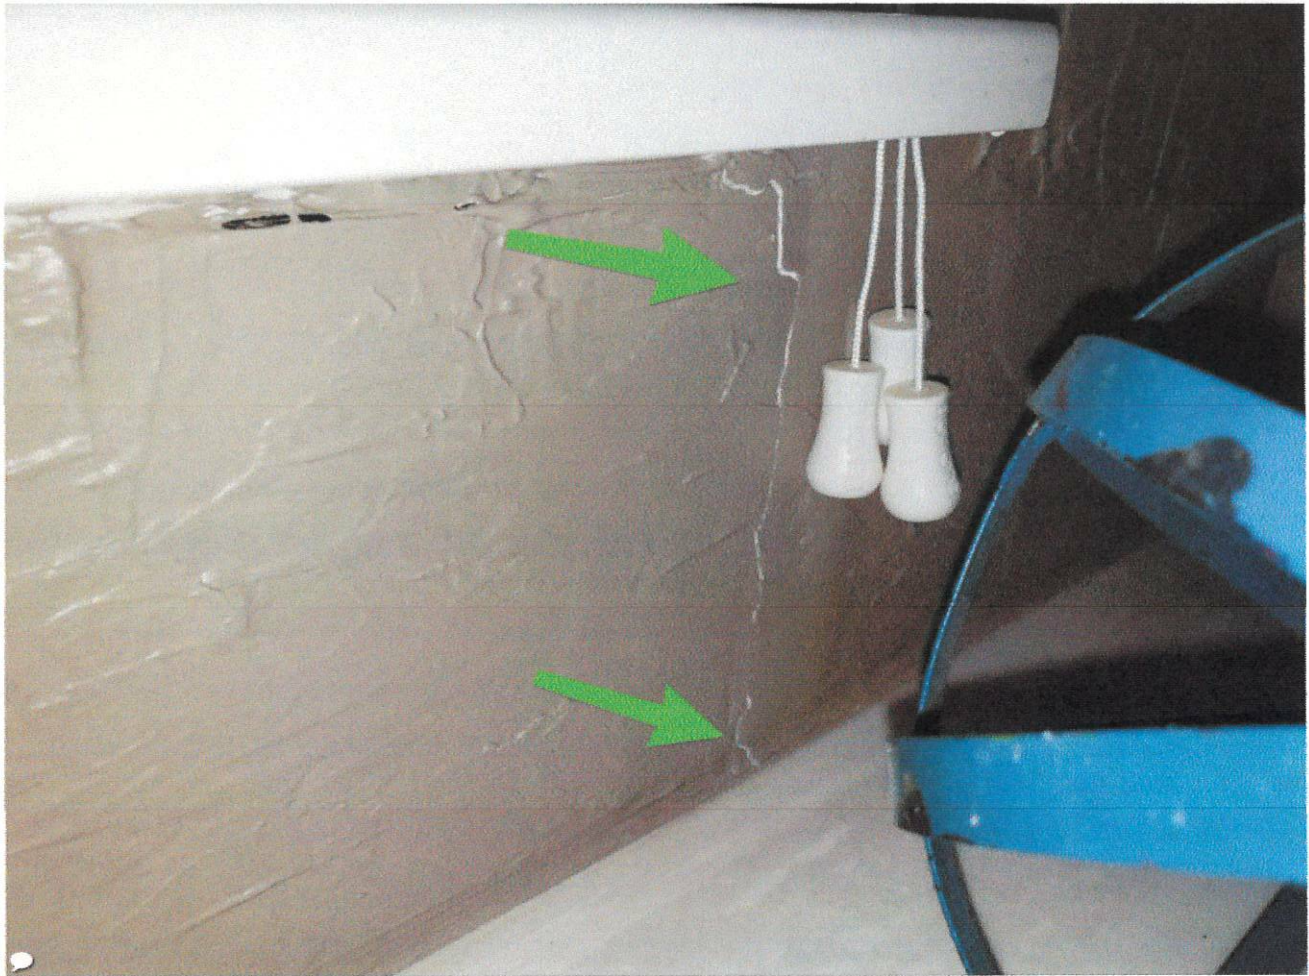
**Walls: Minor Drywall Cracks**

Minor cracks noted at various areas of interior walls. These types of cracks are typical for the age and type of home and should be monitored and/or repaired. If they worsen or recur frequently, consider contacting your inspector, or a structural engineer for further evaluation.
